Installation of an environmental monitoring system in the Chapel of Our Lady of Guia, Macau

Zhong Tang & Shi-Bing Dai

Keywords: Chapel of Our Lady of Guia, Conservation, Diagnostic techniques, Environmental monitoring system

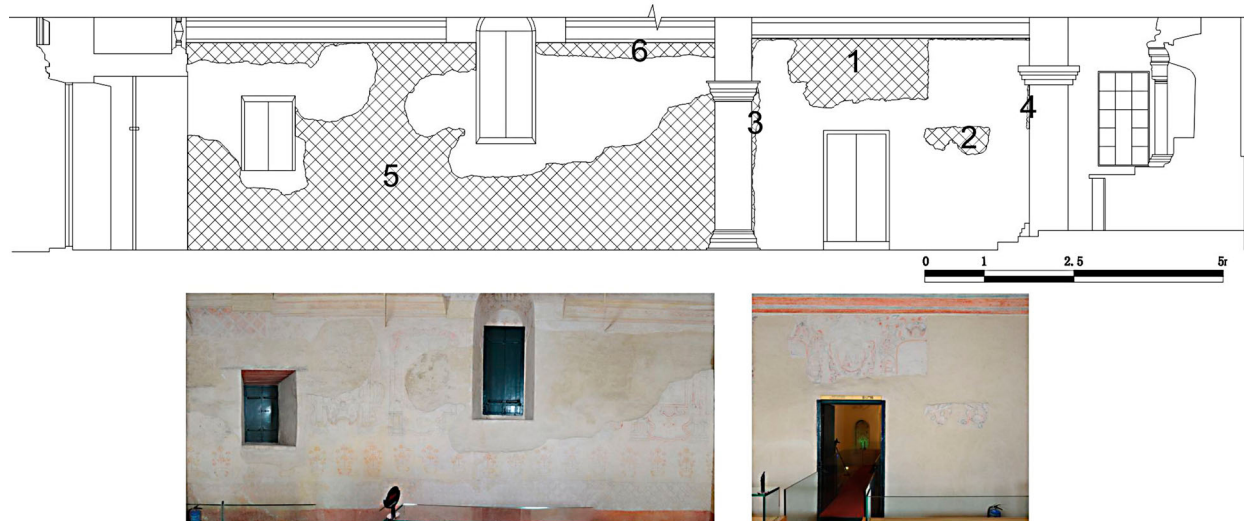
Figure 4 Status analysis of the remaining paintings on the south walls of the front hall and nave. Left: south wall of the front hall. Right: south wall of the nave

Number	Areas of remaining painting	
1	2,310,524mm ²	
2	377,898mm ²	
3	132,274mm ²	
4	25,229mm ²	
Total area of remaining painting on the south wall of the nave		2,945,925mm ²
Original area		14,060,574mm ²
Percentage remaining		20.95%
Number	Areas of the remaining painting	
5	17,535,752mm ²	
6	699,095mm ²	
Total area of remaining painting on the south wall of the front hall		18,234,864mm ²
Original area		27,798,084mm ²
Percentage remaining		65.59%

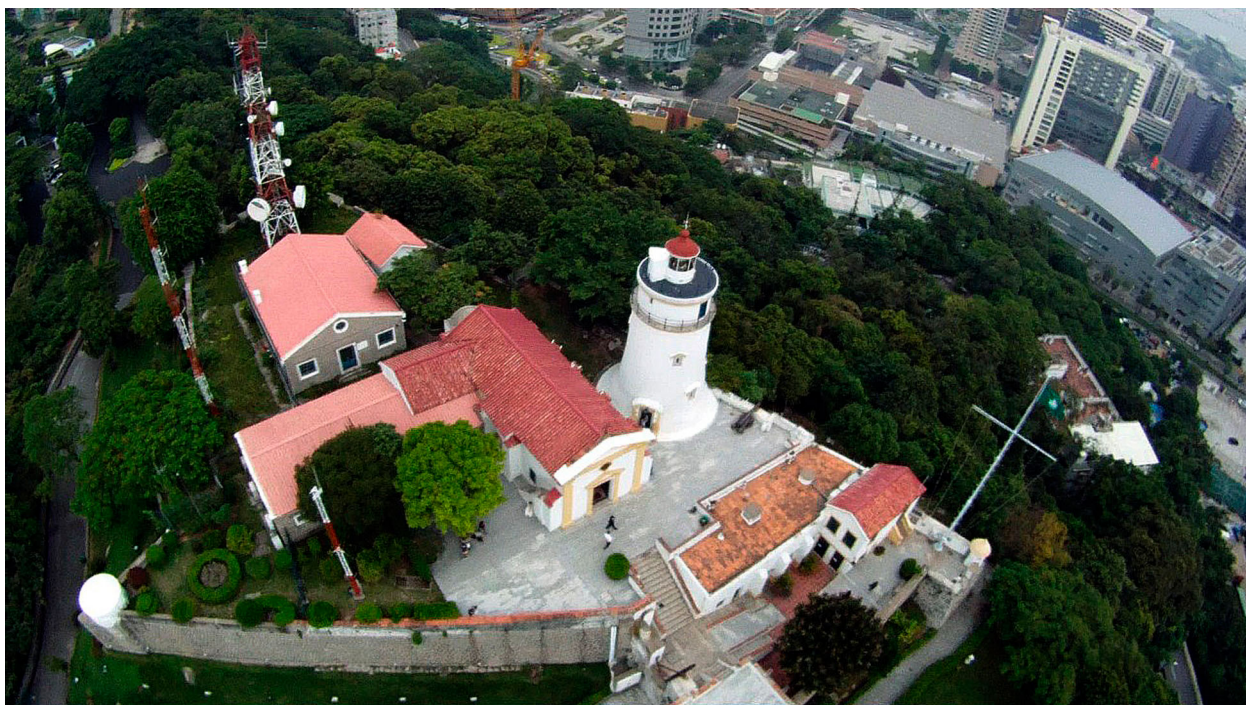
In order to record the condition of the roof, the digital camera was fitted to a drone (Fig. 7). The drone has four power rotors, allowing flying, hovering and rotating. It also has the advantages of steady flying, flexible control, heavy loading capacity, and vertical take-off and landing.

Figure 7 Aerial view taken by four-rotor drone.

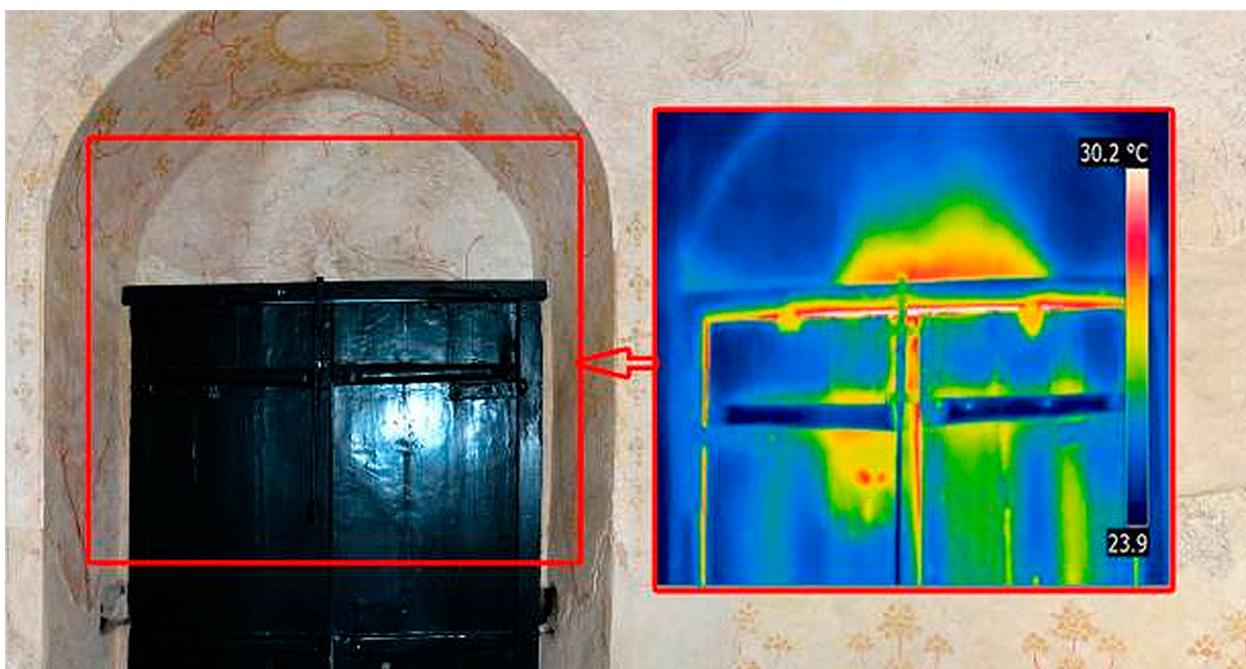
From the thermogram, we found that the interior temperature of the Chapel was not uniform and there were large differences in the surface temperature of the paintings above the doors and windows (Fig. 8). This is because the traditional wooden doors and windows are not airtight, ambient air with a higher temperature leaks into the Chapel through the gaps around the doors and windows and affects the surface of the paintings indoors.

Figure 8 Surface temperature difference of wall paintings shown on thermogram.

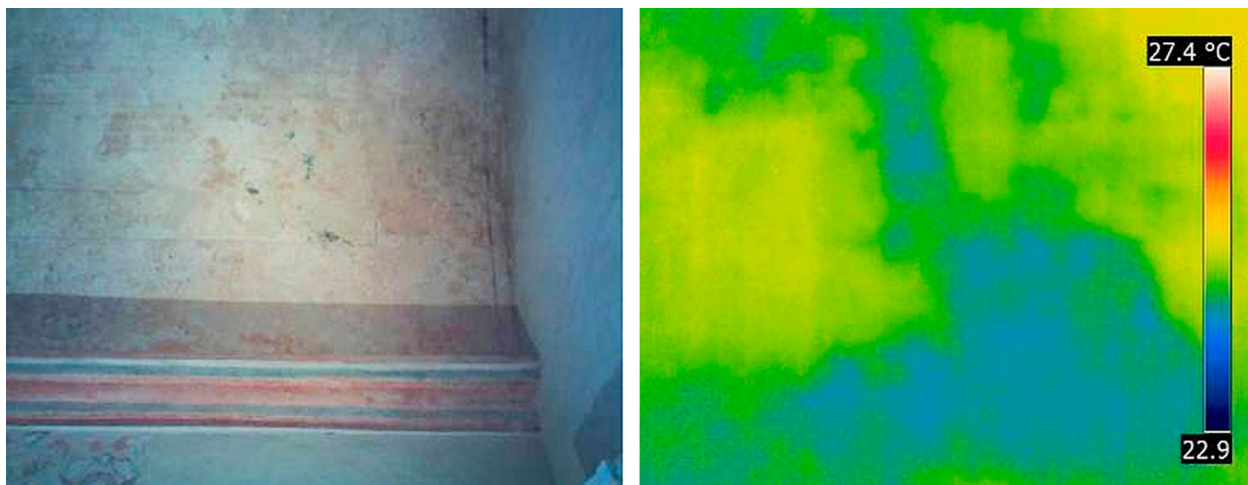
The thermogram also showed an uneven temperature distribution in the roof of the Chapel even though there were no doors and windows (Fig. 9). After close examination, we found mildew in the area with lower temperature. This could be the result of roof leakage. The water lowered the temperature of these areas, and caused the growth of mildew on the paintings. Combined with evidence

from previous aerial photos, it is certain that the leak takes place where the ridges of different sections of the roof join, so it is very urgent to repair the roof.

Figure 9 The thermogram shows that the temperature of the area affected by mildew was lower.

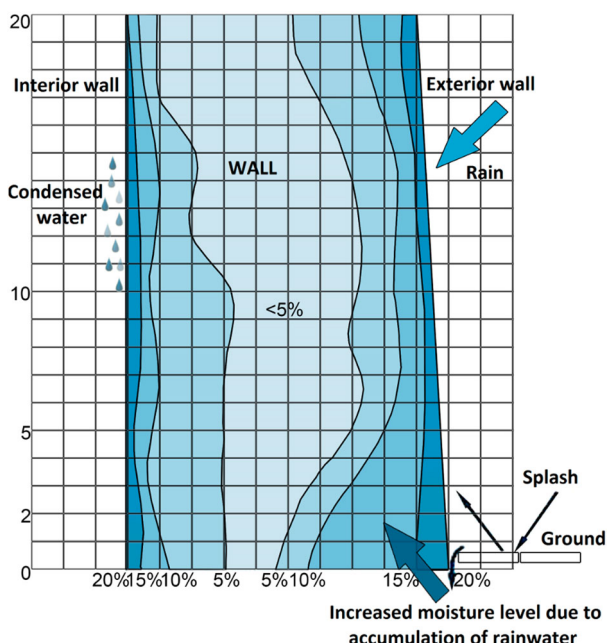
By measuring the moisture content at different depths in the walls of the Chapel, it was concluded that the existing coating on the wall had already lost its waterproofing ability and that water can penetrate into the walls; because of the thickness of the walls, the rainwater affected the interior less. Rainwater was the source of moisture in the exterior walls, and

the moisture at the bottom of the walls was caused by rainwater and splashing. The high moisture content on the surface of the ground layer may be due to water condensation after switching off the air conditioner during the night.

Figure 10 Humidity distribution in the interior and on the surface of the wall of the Chapel with cause analysis.

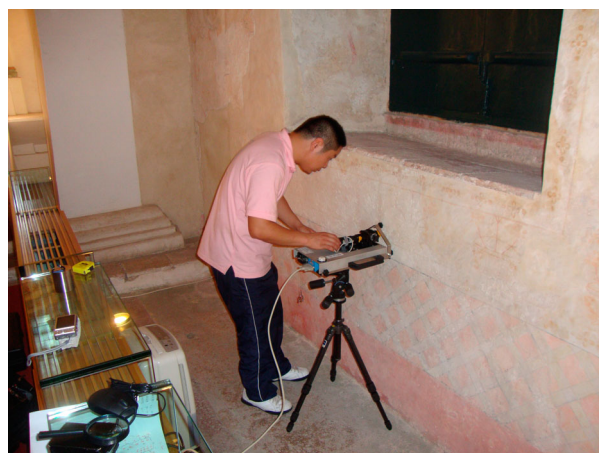
The results indicated that the strength increased sharply after drilling to a depth of 10–20 mm. With microscopic examination and identification of the composition of salts in the materials, we confirmed that the original ground had two or three layers, and that the total thickness was between 10 and 20 mm. The bottom layer was light yellow lime plaster with clay added, and the wall face was white and almost pure lime (lime mortar mixed with paper strips or straw). There were residues of straw in the two layers, so they were probably traditional Chinese rice straw lime mortar. The strength analysis showed that the interior was high-strength stone masonry.

Figure 11 Penetration resistance testing the interior and surface of the wall of the Chapel.
