Maintenance Concept of the Rammed Earth Finishing of the Historic City Wall of Pingyao Shanxi Province, PR China-based on re-evaluation of mock-ups in 2007

KEY WORDS: Pingyao, Rammed earth wall, maintenance, lime earth plaster, adobe

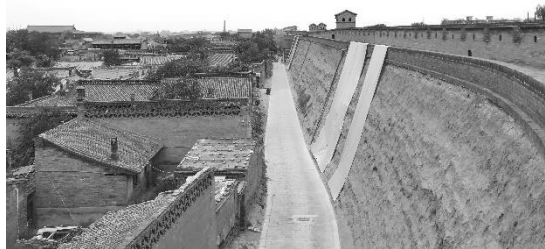
Although many restoration campaigns and daily or weekly maintenance efforts have been done in the past three decades, parts of the city wall are still in danger to collapse (Figure 1). In order to develop an effective but sustainable restoration and maintenance method for Pingyao city wall, in 2006, a research team has been organized under the guidance of the former Chinese Cultural Relics Research Institute (now China Academy for Cultural Heritage), the Bureau of Cultural Relics of Shanxi Province, Pingyao County Cultural Relics Bureau and other organizations. Comprehensive research works have been carried out to systematically analyze conditions^[2,3,4] and the causes of deteriorations. The quality of restoration done in the past maintenance practices was also evaluated.

Figure 1 Internal rammed earth finishing of the Historic Wall of Pingyao (photo taken in 2018). The areas covered by plastic sheets are in danger to collapse.

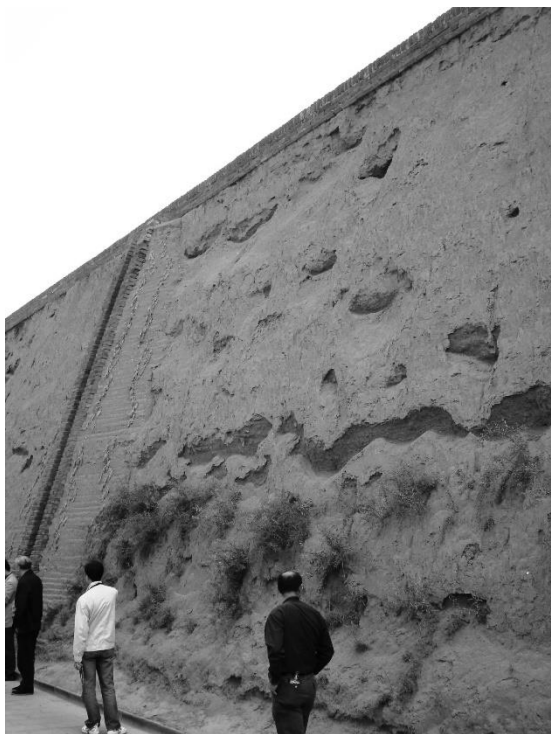
Laboratory tests show that the loess soil, the main construction material of the Pingyao city wall, is poor in clay⁵. It is not water resistant without any treatment. The stability of earth finishing is affected first of all by erosion on the surface or along cracks (Figure 2) or joints. During rainy seasons, the loess soil can easily be eroded. The second deterioration factor is the leakage through cracks especially along parapet walls and capping pavements. The third factor is the salt damages due to high evaporation.

Figure 2 Erosion of earth and repeated maintenance (photo taken in 2006)

structural archaeological earthen sites^[6,7], but the field experiments in Pingyao inner earth finishing showed that the maximum penetration depth of the impregnation reinforcement agent (ethyl silicate in 99%-concentration) was only 150 mm, which is insufficient to protect the existing rammed earth surface like the eroded earthen finishing shown in Figure 2.

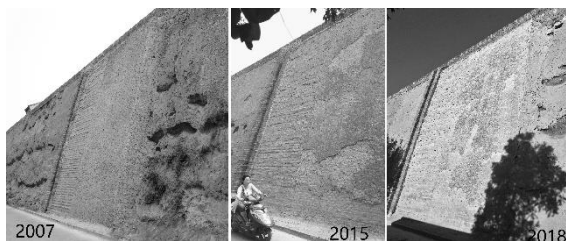
The two mock-ups of “earth on earth” option were done in 2007 in the eastern Wall. The first mock up wall was rammed with lime improved earth. The second one was to build supporting wall with adobe plastered subsequently with lime-earth mortars (Figure 3).

Figure 3 mock-ups finished in 2007 and inspection in 2015 and 2018

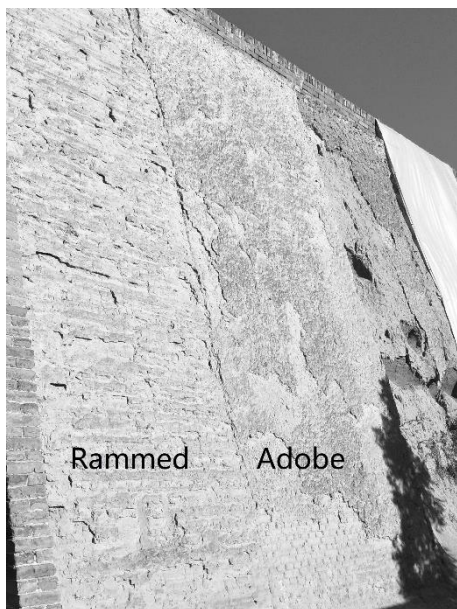
A renewed visual inspection has been done in Sommer 2018. It has found out that the rammed earth surface was still in good condition, although there was obvious surface deterioration. App. 5-30 mm soil has been eroded based on the height of glass fiber, which was used with intention to lower the surface tension.

Figure 4 Visual Inspection of mockups near in Sommer 2018

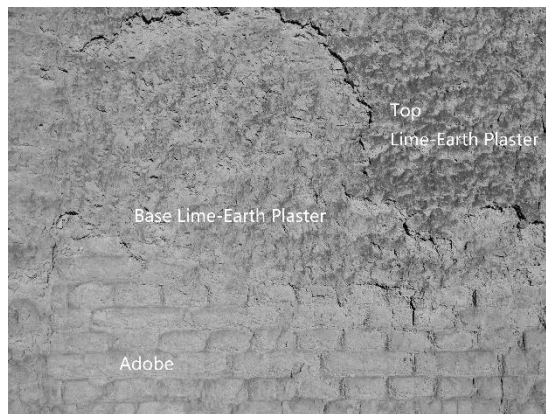
It has also been found the lime-earth plaster to adobe wall in the test area was surprisingly well preserved.

Figure 5 Condition of plastered adobe near most critical area completed in 2007 in details (photo taken in 2018)

There was only app. 20-30% earth plaster has been peeled off after 12 years exposure to natural climate. The delamination occurs both between adobe and base plaster, some delamination has occurred between the base and top plasters. The adobe underneath the lime-earth plaster was relatively well preserved.

The colour of both mock ups are slightly different. The plaster looked darker because more dusts were accumulated on the surface.

The mostly damaged plaster occurred at the top and near foundation. The water repellent impregnation with silicone solution seemed to have not functioned as wished.

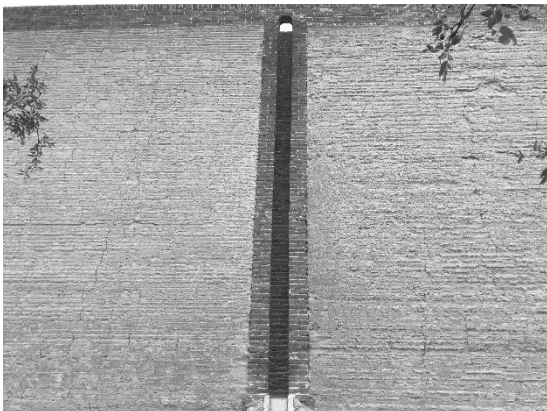
Ramming is an effective method to protect the rammed earth walls while retaining the internal compaction. But the completed areas during 2012-2015 show certain surface deterioration or cracking after a few years' exposure based on visual inspection done in 2015 and 2018 (Figure 6). Those kind of surface defects might not be so extensive to affect the stability of the entire wall, but the causes need to be further studied. From our point of view, a maintenance measurement might be necessary.

Figure 6 rammed earth with cracks and surface deterioration app 3 years after restoration (photo taken in 2015)

The lime plaster could be applied to the rammed earth wall when cracks and clear surface deterioration occurs. Once the rammed surface deteriorates, there is less appearance difference between rammed finishing and rough lime-earth plaster. Such lime-earth plasters can be repeated every 10 -15 years to avoid most expensive major restoration work. After submitting the final report by the China Academy for Cultural Heritage in 2007, no further research works have been carried out. The quality-related researches are necessary not only to monitor the historic city wall, but also to understand the quality and durability of implemented maintenance measurements. A small laboratory on site to test some basic parameters, like density, water content, under technical support of a scientific committee is necessary.
