Lime-based Materials and Practices for Surface Refitting of Cultural Heritage

Key words: Cultural heritage, historic surface, refitting, Huashan Pictographs, natural hydraulic lime

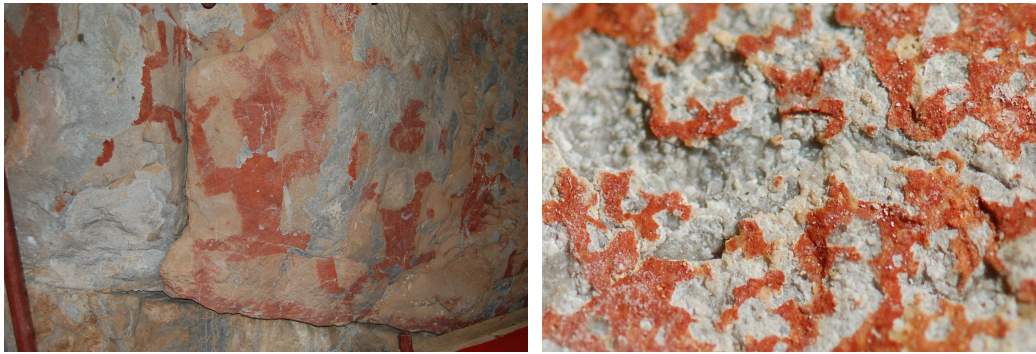
Figure 2: cracks (left) and desolving of painted limestone surface (right)

The main defects are cracks along the cliffs: parallel or horizontally. The width of cracks ranges from micrometer up to several centimeters (Fig. 2). Microscopic studies show the hole space behind cracks are filled with dusts, carbonate and clay sedimentation, insect bodies etc. Those contamination can not be thoroughly cleaned. Ants are also found to settle in the cracks. The refitting needs special caution. Very critical is the desolving of painted limestone, by condensation water, the pictographs are fading (Fig. 2).

The preliminary studies show the limestone is very dense with porosity of less than 5%. The cracks are mostly caused by thermal expansion and shrinking. The urgent measurement is to fit cracked surface to make it safe.

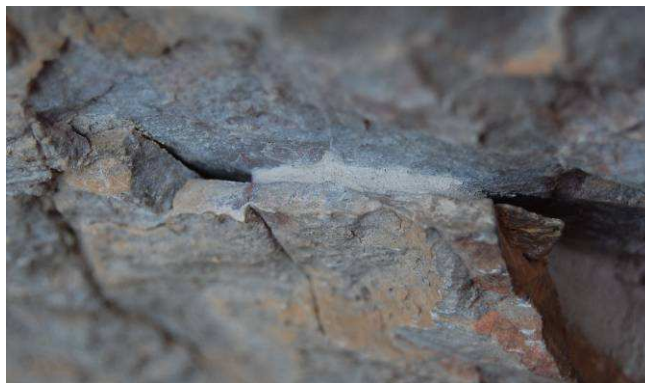
Figure 4: Pointing to hold cracked limestone

Because of positive results both in laboratory and on site, the rescue work of phase I has been started in Nov. 2009 to consolidate most severe damaged surface (Fig. 4). The CFM was mixed on site and filled into app. 50% cracks. The pull-off strength was tested also in local laboratory. Further testing was carried out direct on areas of pictographs. New evaluation will be done in Sept 2010 in order to finalize the receipts, application process and quality control criteria.
