# Structural Analysis of Historical Constructions

# Conservation and Restoration on Cement-Based Renders of Built Heritage in Shanghai, PR China

Wukang road is regarded as the celebrity road, located in Xujiahui district. The case, Wukang Residence is a building group, including 4 units. The former restoration is unreasonable because it changed the whole south elevation and part of north elevation from pebbledash render to common yellow flat painting (Fig. 1).

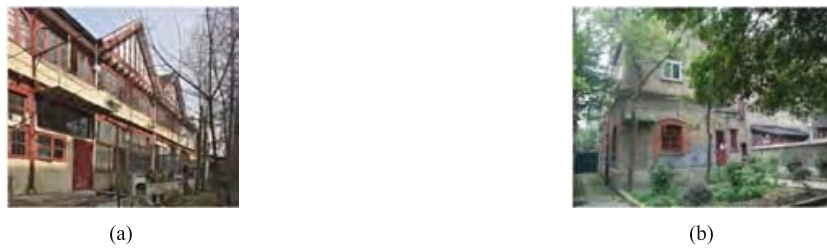
**Fig. 1.** (a) The south elevation (covered with flat plaster), (b) the north elevation (original render is kept partly)

The original pebble dash wall covered by painting will be exposed by cleaning on the new restoration scheme. Some severe damaged parts were replaced due to the hollowing voids and cracks in large areas. In order to get the appropriate sample for replacement and infer the possible application process, the two samples were selected, one(D2) from the east elevation which is the most valuable due to facing Wukang road directly (Fig. 2a) and the other sample(D1) from the north elevation since some

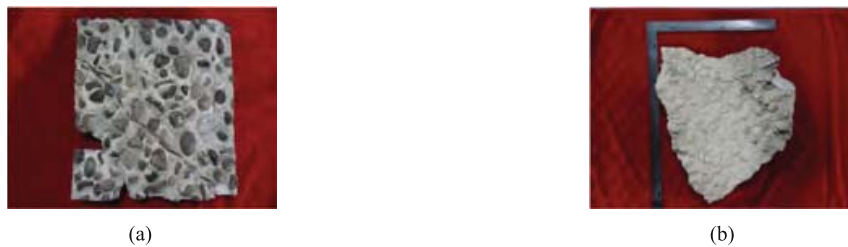
uncovered pebble dash parts provide the initial naked eye’s observation and taking the sample from the damaged part of exterior north wall is non-destructive (Fig. 2b).

**Fig. 2.** (a) Dash pebble uncovered with coating (D1), (b) dash pebble covered with later coating (D2)

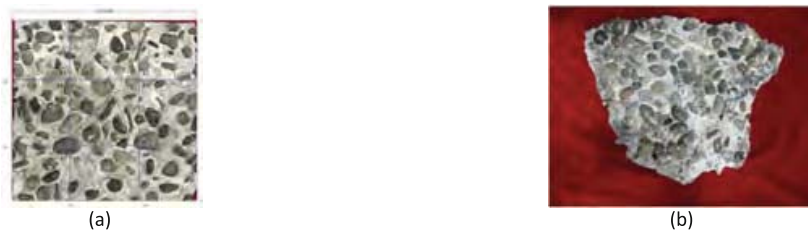
The sample D2 was cleaned at the laboratory (Fig. 3b). Compared with D1, dark pebbles of D2 were less. Initially, D1 was regarded as original dash pebble. The composition of D1 was analyzed at Fig. 3a and Table 2.

**Fig. 3.** (a) Pebble distribution diagram (D1), (b) dash pebble cleaned coat (D2)

From the above, the pebbles composition, to be concluded, is black pebble 40%, grey white pebble 30%, yellow pebble 25% and brown pebble 5% (the volume ratio). The different size distribution of black pebbles: 25 mm occupying 27%, 15–25 mm occupying 27%, 10–15 mm occupying 36%. Grey white pebbles size distribution: above 25 mm occupying 36%, 10–20 mm occupying 45%, the rest below 10 mm occupying 19%. Yellow pebbles size scope is from 12 mm to 21 mm and the brown pebble size is 26 mm.

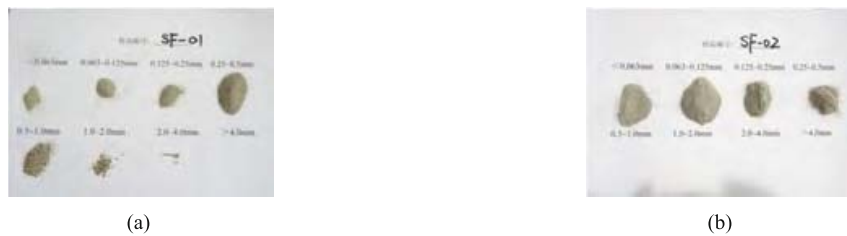
**Fig. 5.** (a) Aggregate grading of D1, (b) aggregate grading of D2

The binder ingredients of D1 and D2 were tested by laboratory with the wet chemical method (Fig. 5). The conclusion is as follows: the binder of Sample D1 is lime-based mortar mixed with sands, less cement and less straw and tow. The ration of lime to sand is 1:1. The main aggregate is the fine sands with 0.25–1.0 mm (Fig. 5a). In addition, the original hydraulic composition occupies 10% or so. The binder of Sample D2 is lime mortar with a high quantity of straw. The original ratio of lime to sands is 3:2.

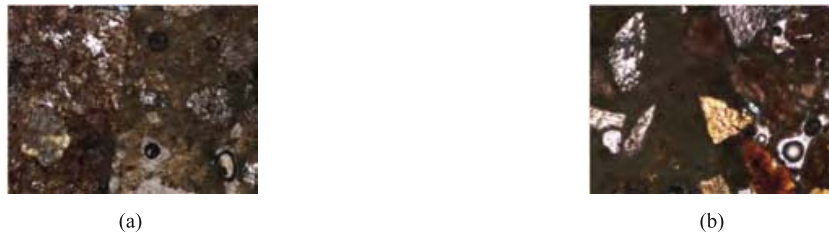
**Fig. 6.** (a) Interface between pebble and mortar (lime-based) of D1, (b) interface between brown and scratch coat of D1

Before the final decision of replacement composition, the analysis was carried out by transmitted-light microscope through petrography. Figure 6a shows that the pebbles (left) and the lime-based binder (right) has a tight cohesion. However, Fig. 7b shows the crack in the middle of the brown scratch between the lime mortar and coarse aggregate. The possible reason is that the lime hadn't got enough time to set and the lower original hydraulic composition is another illustration for this phenomenon.

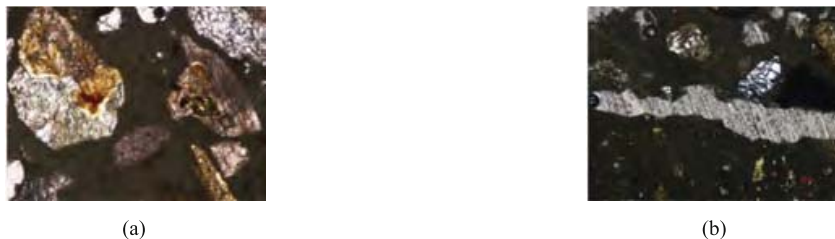
**Fig. 7.** (a) Lime-based (mixed less cement) brown coat of D1, (b) interface between sand and mortar (lime-based) of D1

Because of no cement in scratch and brown coat of sample D2, D2 tends to be considered the original materials. Further, the east elevation provides vital vision to the city so that the east render was decided to be preserved by injecting to consolidate. Considering that the pure lime mortar as brown and scratch coats has a weak performance to the moisture and rain etc., D1 was selected to basis of experimental sample. At the same time the replaced pebbles according to D1 (different from the original D2) provides the readability of restoration. But at the specific ratio and thickness, the sample components have a slight changing to get the better durability and avoid the crack like Fig. 7b due to excess lime causing short set. The final decision made to

repair the exterior wall with the binder (the brown and finish coat) is: lime 40%, fine sands 40%, grey cement 10%, straw 10%. From the case study, the scratch coat includes cement and sands. The brown coat is mixed with cement and lime since the mixed mortar with lime has a good performance in shrinkage resistance. And the finish plaster includes the lime layer and cement layer, considering that cement provide the high bonding strength and the white lime provide the aesthetic visual effect by high contrast to main dark color of pebbles.
