PRELIMINARY STUDY ON LIME MORTARS USED FOR STONE MASONRY OF THE GREAT WALL BUILT BY MING DYNASTY IN CHINA

Abstract

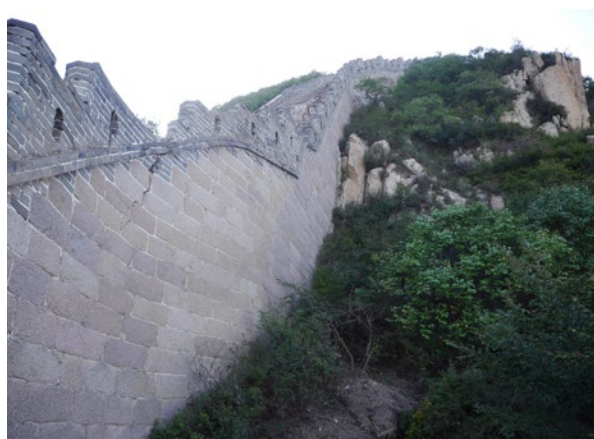
Figure 2: Wall surface from granite and bricks with white dolomitic lime mortar showing cracks and delamination, Source: Dai Shibing

Despite of many restoration campaigns and reconstruction activities in the past four decades (WHC, 2018), parts of the Great Wall are still in danger to collapse (Fig. 2), even shortly after restoration.

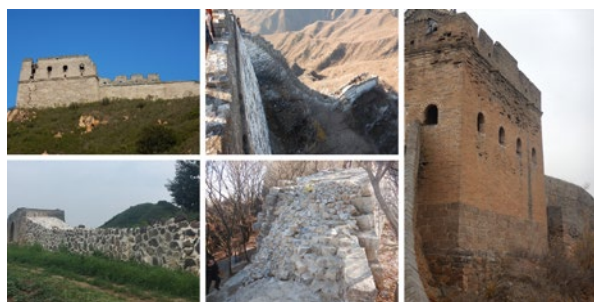
Figure 3: Wall constructed with natural stones in Beijing, Source: Wang Yijie

The Great Wall is constructed with local materials. At least four types of wall constructions can be distinguished. The first type of wall is built with natural stones and bricks mostly filled with natural stones (Fig. 3). For long stretches it only consisted of accumulated stone remnants with well dressed (mostly local) natural stone as a foundation and less well worked natural stones as a whole body. The second type of the wall is based on a stone foundation about 6 meters wide; both wall sides were usually built from bricks whose interstices have been filled with various materials, in partic-

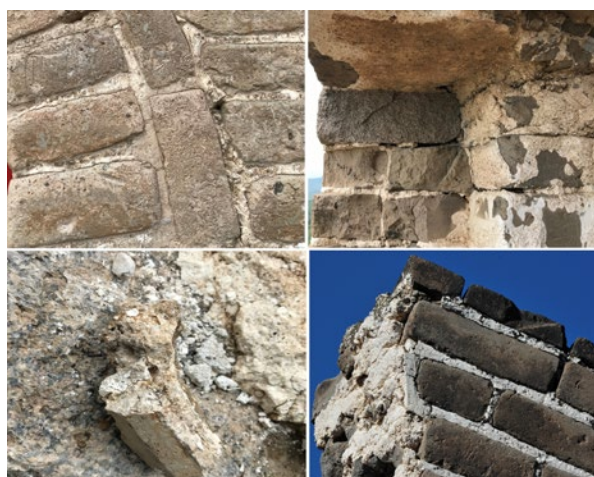
Figure 4: Pointing and bedding mortars (above calcium lime with hydraulic components, below dolomitic lime). Source: Dai Shibing

Lime mortars were extensively used for bedding and pointing (Fig. 4), but also for grouting of voids within stone/brick masonries and stabilisation of soils. Lime plasters were also found in few watch tower ruins. But only the bedding and pointing lime mortars will be further discussed in this paper.

Visual investigations showed that both bedding and pointing lime mortars are made of pure lime with very few aggregates (Fig. 4). In most cases bedding mortars are the same in colour and texture

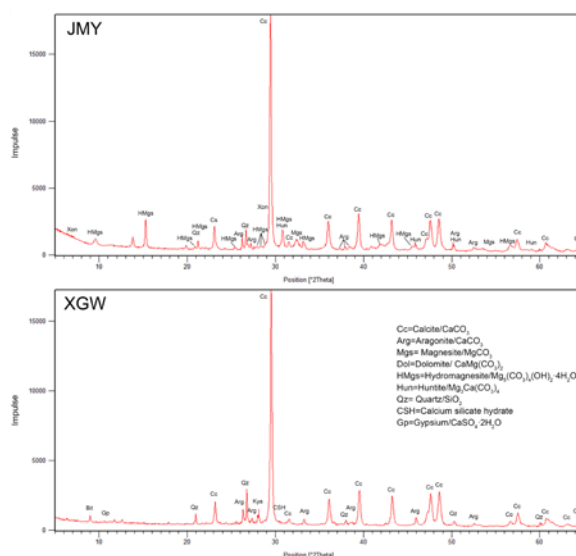
Figure 7: XRD of two typical lime mortars (JMY: dolomitic lime; XGW: calcium lime with hydraulic components). Source: Dettmering/Middendorf.

X-ray diffractometry from comparative samples provided evidence for a magnesium-rich carbonate, huntit as well as its conversion form hydromagnesite (Fig. 7). Magnesite, carbonating next to calcite during the hardening process after firing and the subsequently slaking process, shows a higher

solubility behavior, forming hydromagnesite in the presence of moisture. The distribution of hydromagnesite has led to a partial dissolution phenomena and a recrystallization to less soluble gypsum (Fig. 6). Semiquantitative X-ray diffractometric analyse of JMY (Fig. 7) determined by Rietveld provided predominantly calcite (> 57%, 5% aragonite), hydromagnesite (27%) and magnesite (9%) as phase components, categorized as dolomitic lime known today as DL90-30. The lime mortars from Zunhua in Hebei Province have almost the same properties as XGW.

of wall with an interior surface made of rammed earth and an outer cladding of brickstone masonry. Due to the geology and the appearance of the limes, it is obvious that also silicious and argillaceous limestones were used to build the wall “XinguanWu”, which runs over three mountain passes. Raw materials of the lime mortars had different marl contents. This is partly confirmed in X-ray and wet-chemical analyzes of collected mortars. The average CaO contents of comparative samples are about 39–49 wt.%. The binder proportions vary between 67 and 82 wt.%. The calcium carbonate content determined by Rietveld analysis amounts to a calcite content of 78% and an aragonite content of 10% (Fig. 7).
