ULTRASONIC TESTING OF THE DOLOMITE MARBLE STATUE OF SOONG CHING-LING WITH RESPECT TO THE DEPTH OF CRACKS AND DETERIORATION STATE

Key words: Soong Ching-ling statue, dolomite marble, ultrasonic detection, USCT, cracks

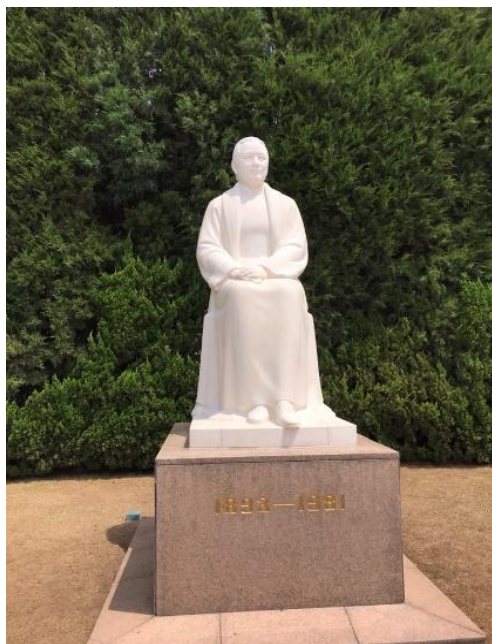
Fig 1: Marble statue of Ms. Song in Shanghai

Madam Soong Ching-ling (Jun.1893-May.1981) was the wife of Mr. Sun Yat-sen, the founder of the Republic of China and honorary Chairlady of the Peoples' Republic of China. The marble statue of Soong Ching-ling stands in the memorial square of Soong Ching-ling cemetery in Shanghai, China (Fig 1). The statue was inaugurated in 1984. It stands 2.52 m high on top of a granite basement, which is 1.1 m high above the ground level.

The statue is composed of 4 pieces of Fangshan Hanbaiyu, a valuable and famous dolomitic marble from Fangshan, Beijing.

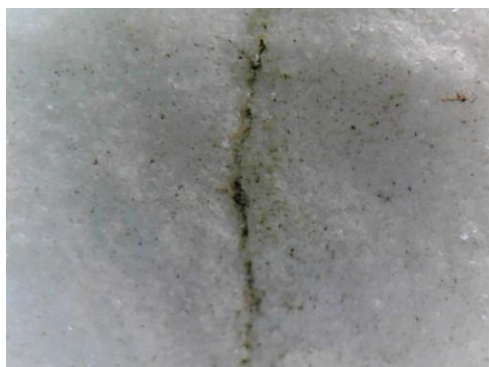
Fig 2: Crack under microscope
The width of the micrograph is 1cm

Since 2014 many micro cracks appeared on the surface (Fig 2), especially on the head of the statue (Fig 3).

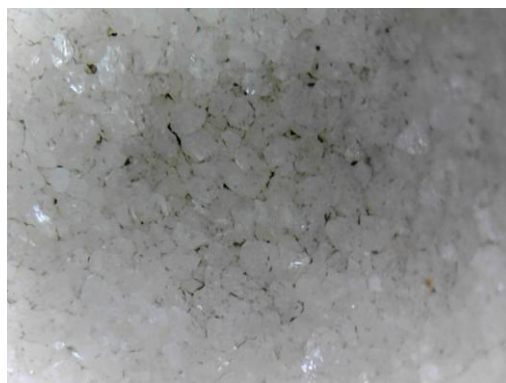
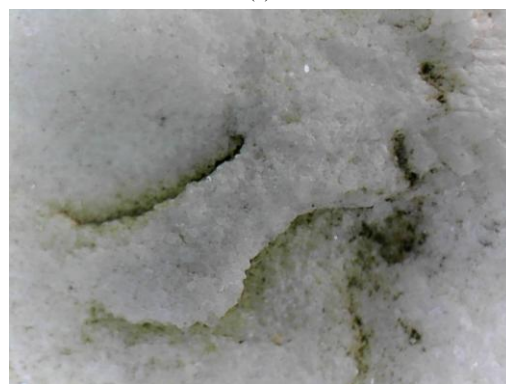
Fig 4: Disintegration of crystal fabric (a) and development of spall (b)
The width of the micrograph is 1cm

Inspection under the in-situ microscope shows different stages of disintegration of the crystal fabric on the surface, and even the formation of small marble spalls (Fig 4).

It is absolutely necessary to fill cracks and crystal gaps with suitable materials to slow down the deterioration process.

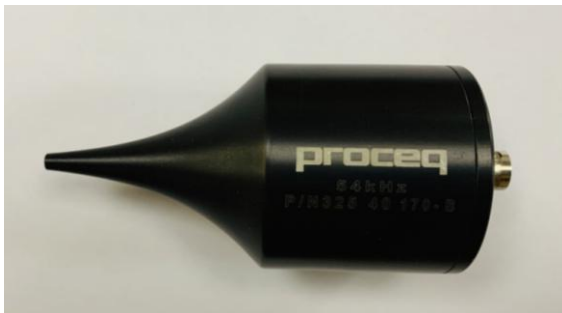
Fig 7: Probe for crack depth detection

The ultrasonic device used was a Proceq PunditLab+, with the precision of $0.1\mu s$ and the probes were Proceq 40 17-B 54KHz conical probes(Fig 7), with the contact diameter area of 4mm, that ensures the precision of the contact points and the accuracy of testing results. Fig 8 shows examples of cracks detected. Table 2 shows the calculated depth results of fifteen cracks and the depth ranged from 0 to 68mm.

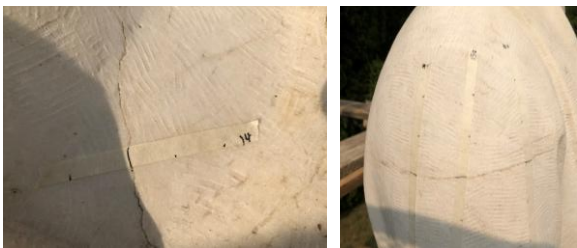
Fig 8: Cracks in the marble of the Soong Ching-ling statue

According to the observation, almost all of the 77 cracks should be developed from the stone interlayers. The depth of 15 cracks has been detected and the results are between 0-68mm. By UCT, a losen zone with thickness up to 50mm has also been found.

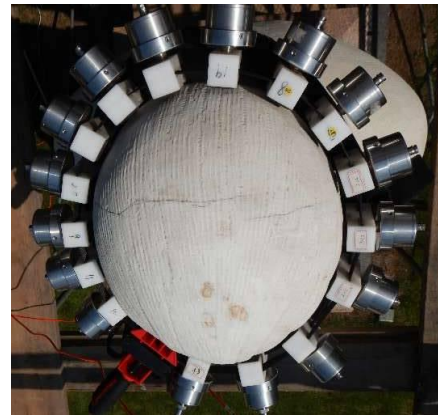
Fig 11: USCT testing section

For the on-site testing of the statue, a section of the cranial region of the statue was chosen as shown in fig 11, and sixteen probes were used. Fig 12 shows the USCT detecting system and USCT images. The ultrasonic velocity in fresh marble similar to the material of the statue is about 4500m/s, and the measured velocities shown in the result images range between 1000-4500m/s
