Stone Conservation in China-with focusing on carbonate stone conservation practice

Shibing Dai¹ Jizhong Huang², Jinhua Wang³, Hongsong Li⁴

1 Architectural Conservation Laboratory CAUP Tongji University, No. 1239 Siping Road, 200092 Shanghai, China

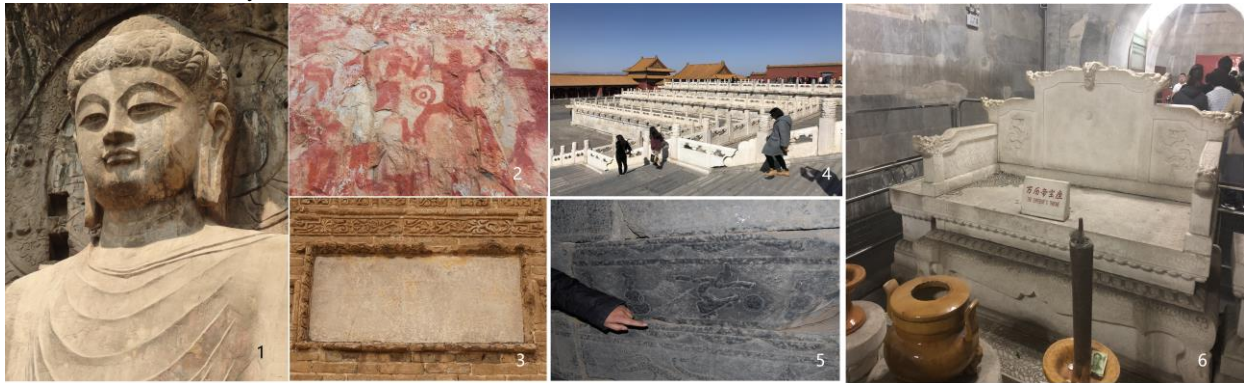
Figure 1 representative carbonate stone monuments which are listed as UNESCO cultural heritage in China

(1=Longmen Grottoes, Buddha statue carved in dolomitic limestone; 2= Huashan pictographs on limestone cliff; 3= lime stone inscription in the Great Wall; 4=carving of football play on the surface of limestone pagoda of Han Dynasty; 6=Empty tomb of Ming Nasty in Beijing), Source: Dai Shibing

China's cultural stone structures and objects are extremely multifaceted. The immovable of them can be broadly divided into three categories (Li Hongsong, 2004), first one is so called grottoes and inscriptions, which are built or crafted directly or indirectly into the geological bodies (Fig 1-1, 1-2). The second one is stone structures of architectural heritage, which are similar to the stone architecture in Europe (Fig. 1-3, 4, 5). The third one is ruins or tombs in underground (Fig. 1-6). The grottoes are built predominantly in sedimentary stones, like sandstone, greywacke and limestone. The largest site of first category is the Yungang Grottoes. The natural stones used as architectural materials vary also from region to region, due to locally available resources and petrology. The greatest

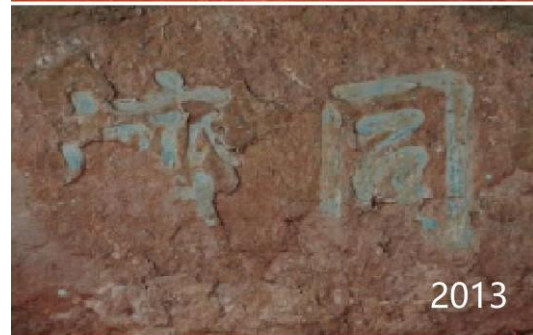
Figure 3 inscription of Tongji (同济) carved on 7 July 1938 on sandstone cliff as the University of Tongji moved from Shanghai to west as the Japan invaded China. , Source: Dai Shibing & Tang Yongjing

There are obviously accelerating deterioration of stone monuments in China (Fig. 3) in the recent decades. Figure 3 shows the inscription was in relatively good condition after app. 70 years although they were carved in clay rich sandstone, but heavily deterioration occurred in last 12 years, this inscription need to be rescued immediately. The causes are not clarified. This may be related to climate changes, air pollutions and lack of maintenances.

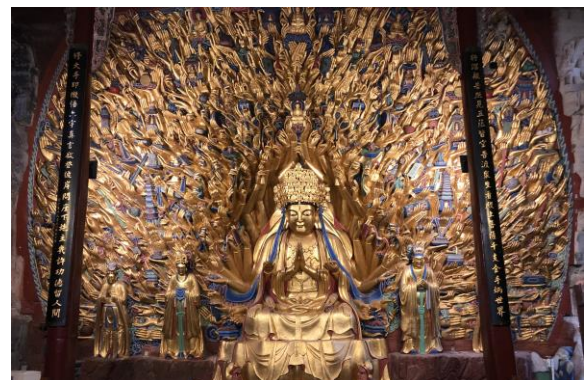
Figure 4 Thousand-hand Bodhisattva in Dazu three years after restoration , Source: Dai Shibing

From 2008 a few national conservation projects were launched. Among them the No. 1 stone conservation project was the conservation of Thousand-hand Bodhisattva in Dazu. This ten years conservation project was organized directly by the State Administration of Cultural Heritage with contribution of over ten research institute and universities. After accomplishment there were debates on the final appearance.

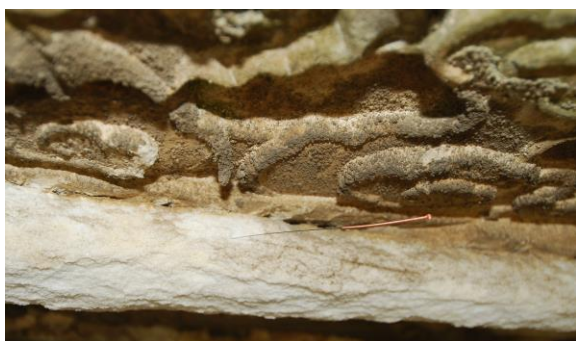
Fig. 6 typical deterioration of dolomitic marble through industrialization (hier Na_2SO_4 dusts attacked dolomitic marble), , Source: Dai Shibing

But the carbonate stone monuments are suffering severe damages especially in the industrial pollution (Fig. 6). Besides cracking, new formation of water soluble salts cause not only the material lose of the carbonate stone, but also damages to historic adjoining materials. Special conservation need to be developed for carbonate stone conservation.

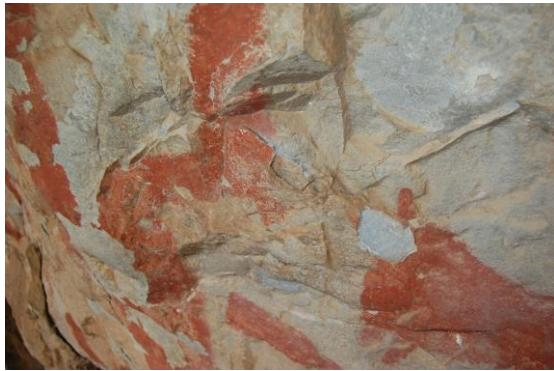
Fig 7 Detachment of limestone and fading of paints of Huashan Pictographs, Source: Dai Shibing

Damage symptoms of the Huashan Pictographs are typically cracking and loss of paints. Crack width, direction and form are varying. Calcium and clay/mud sediments can be found inside the cracks. Loss of paints is not only related to cracking but also to dissolving due to condensation. To rescue such cultural heritage, bonding mortars and injection grouts based on natural hydraulic lime (NHL2) have been developed in 2007. NHL-Bonding agent is composed of NHL2 and additives like redispersable acrylic resin (less than 1wt%). It’s role is to reattach delaminated limestone pieces (pls. s. middle of Fiigure 7). To seal cracks, the formulation is to adjust with liemstone powder according to the widness of cracks. 15-20wt% of 1-2mm limestone particles can be added into NHL-bonding agent to seal crack width larger than 5mm. Injection grout based on NHL2 and superplasticizer is to fill holeness. It has good bonding properties even to clay contaminated cracks. After setting it has high water absorption capacity (over 40wt%) to absorp condensation, which is believed to be main damaging factor for paint fading of pictographs. Both modified NHL-bonding agent and injection grout have low shrinkage, but similar thermal expension coeeficient as that of limestone. They show also higher water absorption and higher water vapour permeability than that of limestone. Because the Huashan pictographs is located in subtropical climate, the frost resistance was not tested.

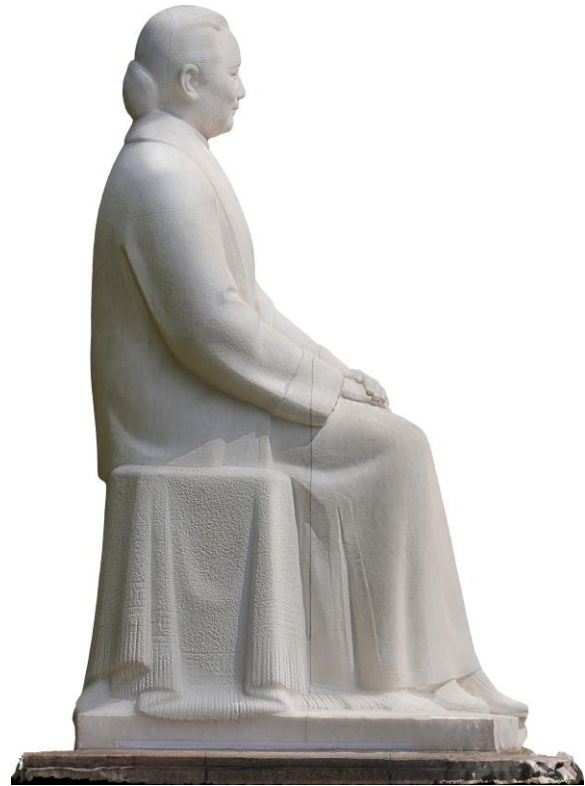
Figure 8 west view of the Madam Song's Statue (@Tangzhong)

The statue was painted white using various polyurathan-modified acrylate paints until 2010. In 2010 it was decided to strip old paints and sealed with water repelling clear sealer with intention to prevent further weathering of the marble from acid rains. This measurement was completed in september 2012. From 2014, there have been many micro cracks (Fig 2) occurred on the surface, especially on the head of the statue (Fig. 2). In May 2018 the architectural conservation laboratory of Tongji University was asked to carry out diagnostic investigation and to work out conservation and maintenance concept.

Under the in-situ microscope, over 30 micro cracks were identified and labeled. The crystal fabric on the surface is becoming loosen with different degrees, even small marble pieces are peeling off. Mineralogically it consists of approximately 92-97% dolomite ($\text{CaMg}(\text{CO}_3)_2$), minor quartz and muscovite have also been identified. This

composition is same as the typical dolomitic marble found in Fangshan near Beijing. Epsomite have been identified in the marble dusts.

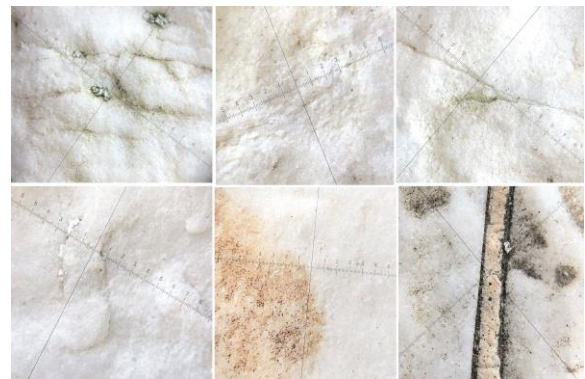
Figure 9 typical macro defects of the dolomitic marble of Madam Song's Statue in Shanghai, Source Dai Shibing

Non-destructive ultrasonic technology, IR-scanning, water absorption, sanding test with tesa-film were applied to evaluate the conditions. The water repellent effect is gone. Surface consolidation tests with micro lime (dispersed $\text{Ca}(\text{OH})_2$ with particle size of 0.2-3 μm in ethanol) and low concentrated ethyl silicate show satisfied results. The pull-off strength of micro lime on fresh cracked dolomitic marble can reach 0.1-0.3 Mpa in 14 days.
