Restoration of Historical Fair-faced Brick Facade in Tianjin Five Avenues, PR China

ABSTRACT

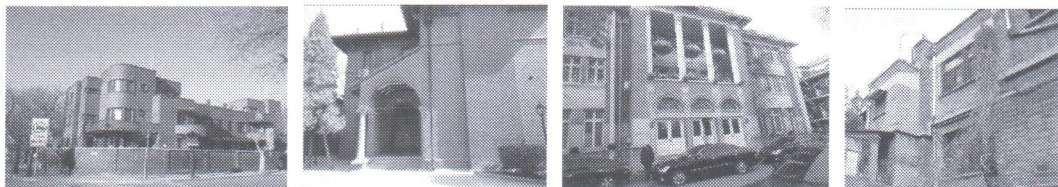
Fig. 1 some of representative historic building of Arts & Crafts in Tianjin Five Avenues from well preserved (left) to in very poor condition (right)

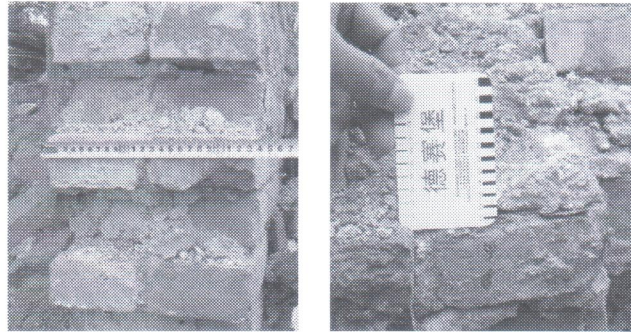
Fig. 2 Construction of masonry built with lime-earth mortar (left) and bituminous sheet (right) as rising damp barrier

All masonries of various stones were laid with almost the same masonry mortar, a mixture of earth from Haihe (a river crossing the city of Tianjin) and lime. The lime and earth mix ratio ranges from 1:3 (very slim) up to 2:1 (very fat) based on the chemical analysis with help of the "Wisser & Knoefel" method.

The means, during the construction time, no quality control had been given to the masonry materials. The bedding mortar is very porous and has very high water absorption capacity, this provide an economic possibility to be treated against rising dampness. Original rising damp barrier was bituminous sheets, which is rotted and has lost its function.

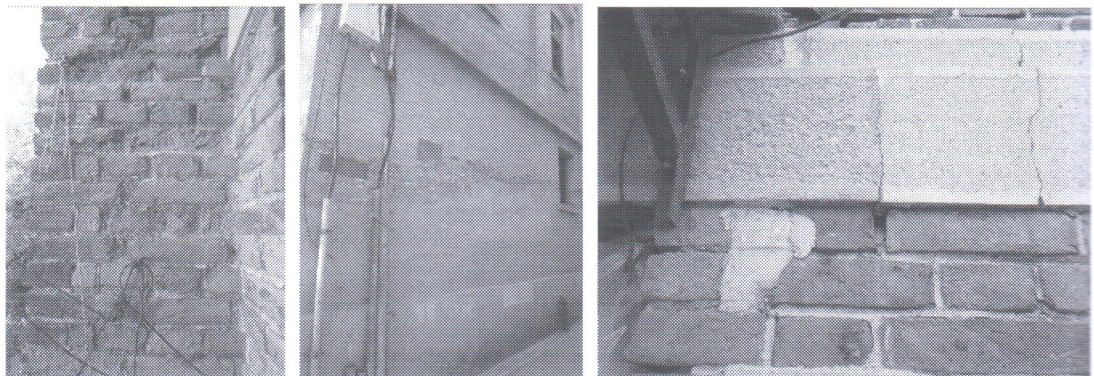
Fig.3 various defects might be related to freezing thaw (left)、rising dampness and wrong restoration methods (middle) and movement (earth quake, right)

The most common defects of the fair faced brick facade in Tianjin Five Avenues are caused by moisture, e. g. rising dampness or leakage of rain water down pipes due to poor maintenance. Some of the walls have suffered irreversible damage from water penetration and freezing, causing the faces of many bricks to pop off.

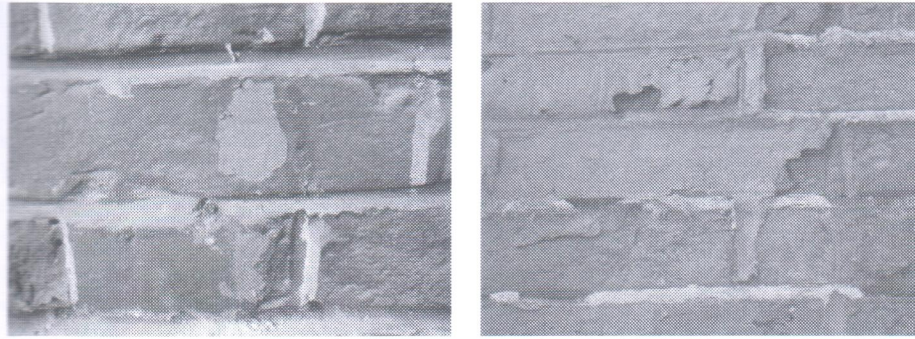
Fig 4 (left) Painted fair-faced brick facade, the stone was painted with dark braun colour, joints with white light grey coating, but historically the joint colour was dark grey – beige after natural weathering; (right) green-grey brick with white modelled joints was painted by grey coating

Due to very deep recessed points, most of fair faced brick facades are not rain water tight. This is one of the reasons that most of the facades are painted with emulsion paints or transparent glossy sealers or even bituminous coatings in the past

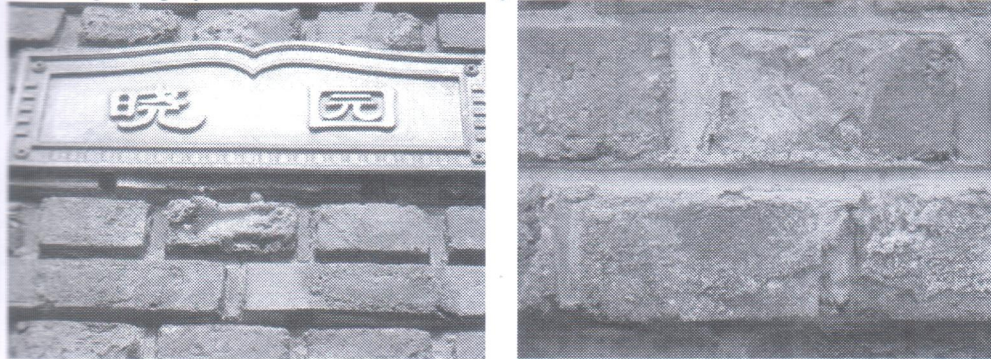
Fig 5 Original deeply recessed joints (left) and repaired with cement which damages entire image of brick facade

decades. Because of leakage, some of bricks were re-pointed with new pure cement, which is neither physically nor chemically compatible to original. This is not only visual defects, but also

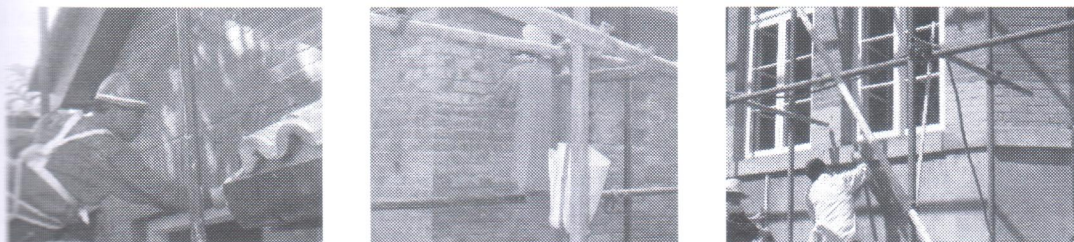
Fig. 6 Façade restoration process (paint stripping, brick repairing & repointing)

- (2) Installation of new functional rain water down pipe to prevent penetration of rain water into wall
- (3) Installation of new rising damp barrier through pressure-less chemical injection, whose effectiveness has been controlled with help of IR-scanning
- (4) Remove old sealer or painting work by using a paste form paint stripper to restore historic finishing
- (5) Restoration of brick using dentist repair, rebuild and reprofile with restoration brick powder (a kind of repair mortar based on crashed bricks, natural hydraulic limes and additives)
- (6) Re-pointing with lime-based fillers, which matches both in form and in colour
- (7) Impregnation of entire façade with water-borne siloxane especially to joints to improve the rain water tightness.

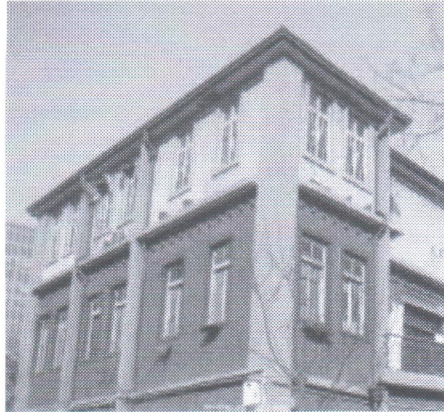
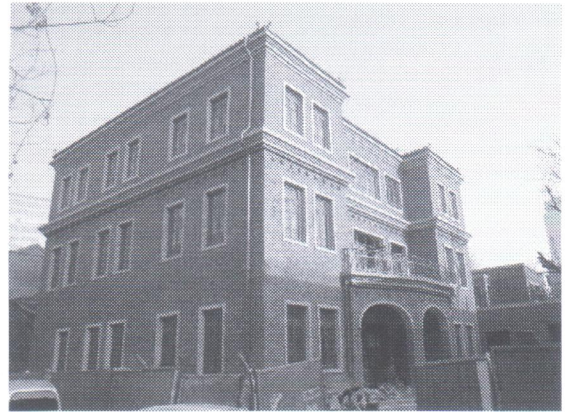
Fig. 8 No. 9 of Hunan Road, before (left) and after (right) restoration

A few historic buildings in the area of Five Avenues Area (located in Hebei Road, & Hunan Road) have been restored with above mentioned

concept and converted into club houses, studios, luxurious restaurant etc.
