STONE CONSERVATION IN CHINA – WITH FOCUSING ON CARBONATE STONE CONSERVATION PRACTICE

Shibing Dai¹, Jizhong Huang², Jinhua Wang³, Hongsong Li⁴

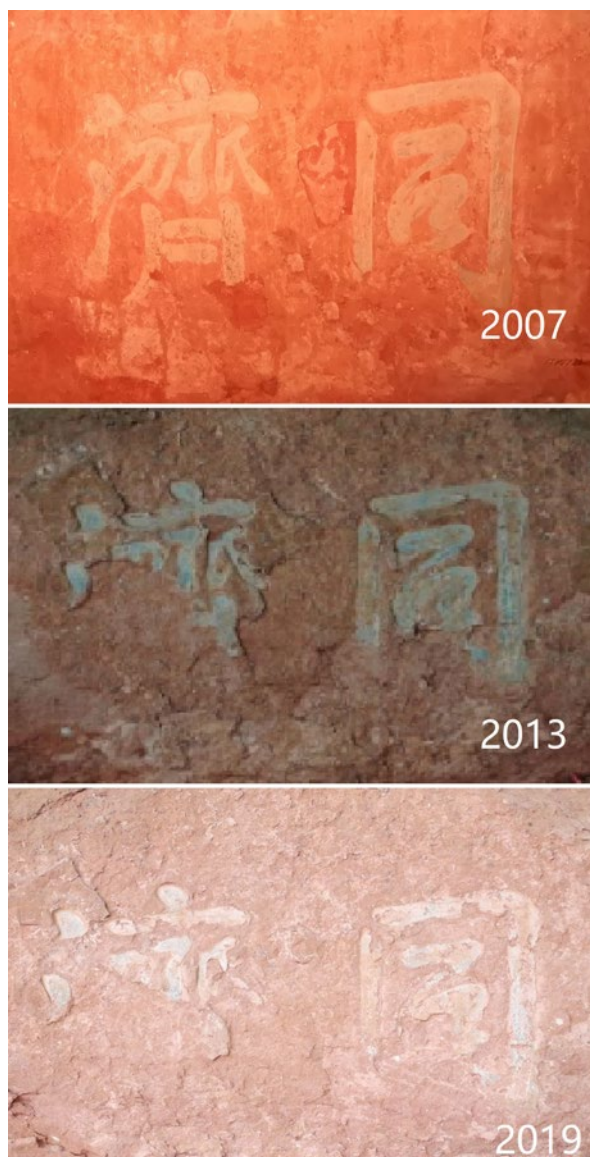
Figure 3: Inscription of Tongji (同济) carved on 7 July 1938 on sandstone cliff as the Tongji University moved from Shanghai to west because of the Japanese Army invaded China. Source: Dai Shibing & Tang Yongjing.

Obviously accelerating deterioration of stone monuments can be recorded in China since the recent decades (Fig. 3). Figure 3 shows that the inscrip-

tion was in relatively good condition after 69 years although they were carved in clay-rich sandstone, but heavily deterioration occurred during the last 12 years. The causes will be investigated. They may be related to earthquakes, climate changes, air pollutions and lack of maintenances. Nevertheless this inscription needs to be rescued immediately.

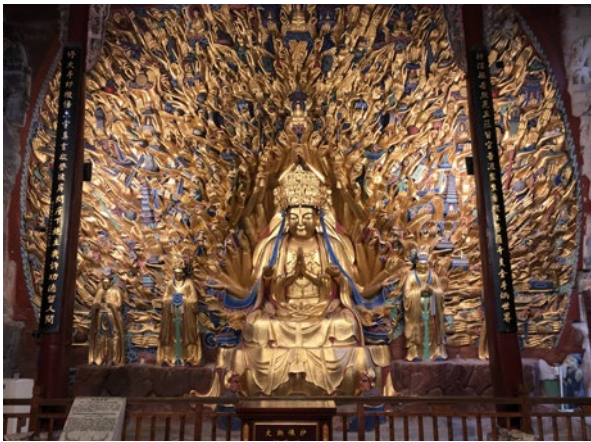
Figure 4: Thousand-hand Bodhisattva in Dazu three years after restoration, Source: Dai Shibing.

contribution of over ten research institutes and universities. However after accomplishment there were debates on the final appearance (Fig. 4).

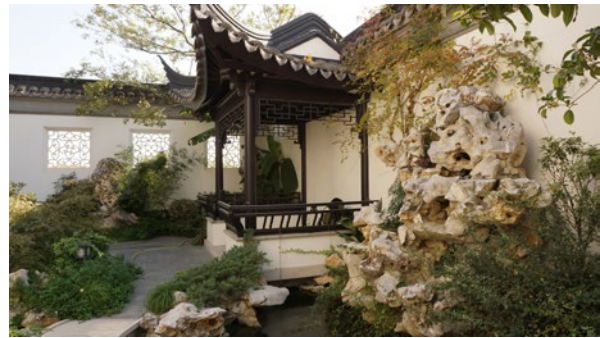
Figure 5: Lime stone is one of the decorated components in Chinese Gardens (hier duplication in new construction). Source: Dai Shibing.

Some limestone species have surrealistic shapes, patterns and forms with feminine charm. Such limestone is called Taihu Stone used as a prestige decorative stone especially in Chinese gardens (Fig. 5).

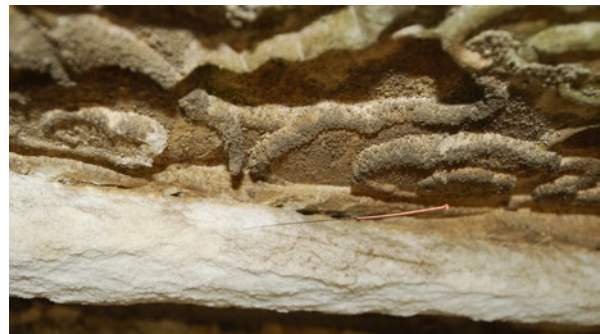
Figure 6: Typical deterioration of dolomitic marble through industrial Na_2SO_4 dusts. Source: Dai Shibing.

However carbonate stone monuments are suffering severe damages especially under the industrial pollution (Fig. 6). Besides cracking, new formation of water soluble salts causes not only material loss of the carbonate stone, but also damages historic adjoining materials. Special conservation concepts need to be developed for carbonate stone conservation.

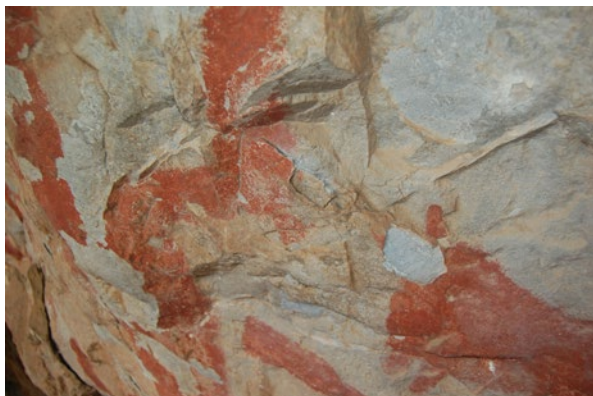
Figure 7: Detachment of limestone and fading of paints of Huashan Pictographs. Source: Dai Shibing.

Damage symptoms of the *Huashan Pictographs* are typically cracking and loss of paints. Crack width, direction and form are varying. Calcium and clay/

mud sediments can be found inside the cracks. Loss of paints is not only related to cracking but also to dissolving due to condensation. To rescue such cultural heritage, bonding mortars and injection grouts based on natural hydraulic lime (NHL2) have been developed in 2007. NHL-Bonding agent is composed of NHL2 and additives like redispersible acrylic resin (less than 1wt%). Its role is to retach delaminated limestone pieces (middle of Figure 7). To seal cracks, the formulation is to adjust with limestone powder according to the width of cracks. 15–20wt% of 1–2 mm limestone particles can be added into NHL-bonding agent to seal crack width larger than 5 mm. Injection grout based on NHL2 and superplasticizer is to fill holes. It has good bonding properties even to clay contaminated cracks. After setting it has high water absorption capacity (over 40wt%) to absorb condensation, which is believed to be one of the main damaging factors for the paint fading of pictographs. Both modified NHL-bonding agent and injection grout have low shrinkage, but similar thermal expansion coefficient in comparison to the corresponding limestone. They show also higher water vapour permeability than that of the limestone. So the condensation within cracks can still evaporate through filled cracks. Because the *Huashan Pictographs* is located in subtropical climate, frost resistance was of no relevance and therefore not tested.

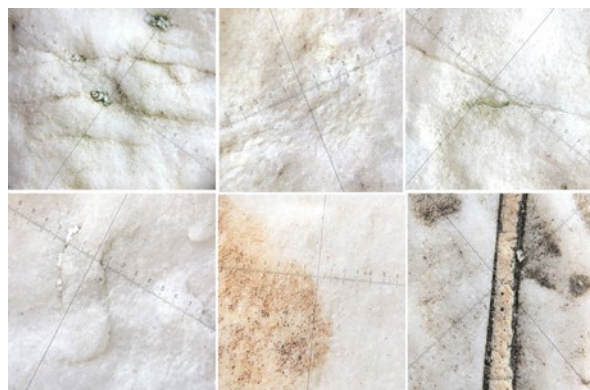
Figure 9: Typical macro defects of the dolomite marble of Madam Song’s Statue in Shanghai. Source: Dai Shibing.

Under the in-situ microscope, over 30 micro cracks were identified and labeled. The dolomite crystal fabric on the surface is becoming loose with different degrees, even small marble pieces are peeling off. Mineralogically it consists of 92–97% dolomite ($\text{CaMg}(\text{CO}_3)_2$), minor quartz and muscovite. This composition is the same as the typical dolomite marble found in Fangshan near Beijing. Epsomite has been identified in the marble dusts at the lower part of the statue.
