# 宁波保国寺大殿宋柱现状监测的无损与微损检测技术研究

Non-destructive and Micro-destructive Testing Technology for Status Monitoring of Song Dynasty Wooden Columns in the Main Hall of Baoguo Temple, Ningbo

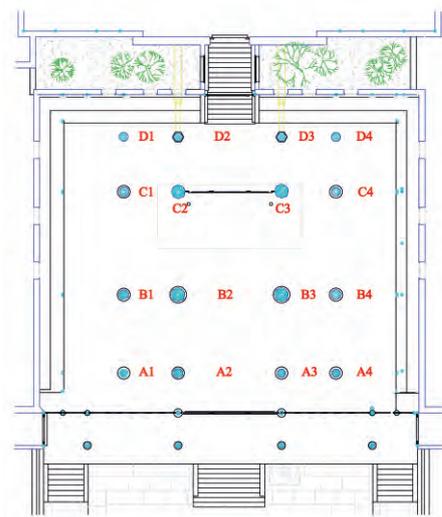
图2 保国寺大殿宋柱分布及编号（图片来源：宁波市保国寺古建筑博物馆）

在保国寺大殿中，木柱是其最重要的竖向受力构件，而大殿内部有16根柱子属于宋柱<sup>①</sup>（图2）。其中7根木柱由较小木料镶拼而成，截面呈八瓣瓜棱状，是现存最早的木构瓜棱柱实例。这种独特的柱身形式是保国寺大殿的重要特征所在，也为监测工作带来了新的特点和难度。

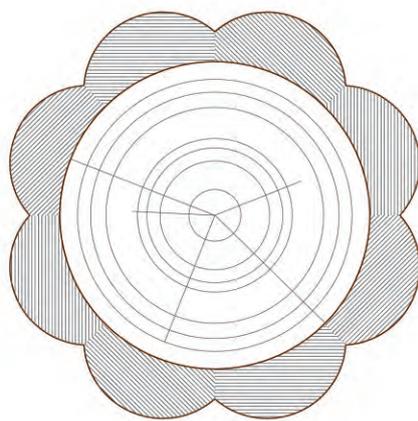
图 3a

宁波保国寺大殿16根宋柱中有7根为拼合柱的构造形式，包括外围八块木料用销子连接，围绕中心木柱形成的八瓣包镶柱（图3a），以及四根木柱合在一起，外加四块木料，形成外围八道瓜棱的四木合柱（图3b）。

图 3 木柱构造示意图（图片来源：陈琳绘制）

3a. 八瓣包镶柱构造示意图

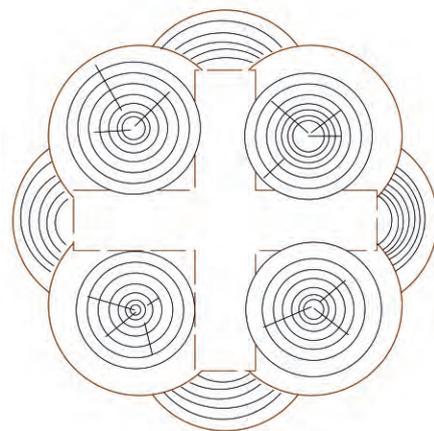
图 3b

3b. 四木合柱构造示意图

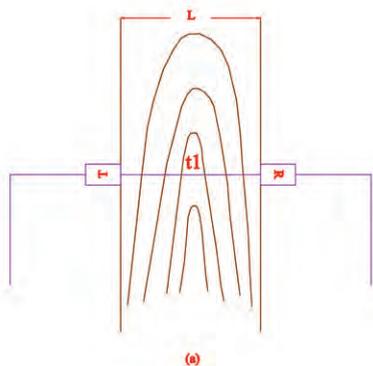
图 4a

D1、D2、D3、D4 距离柱础高度 40 cm, 80 cm, 120 cm, 160 cm、200 cm 的部位进行检测。本次检测采用 24 kHz 频率传感器直接测量法(图 4), 在木柱表面与传感器之间涂抹耦合剂以便贴合紧密(在检测之后需尽快清除木柱上残留的耦合剂, 以免对柱面造成损害)。每个测量点检测两次并记录波速, 最后选取平均值作为该位置的波速。

图 4 超声波检测木材方法示意图（图片来源：同图 3）

4a. 健康木材超声波传播路径

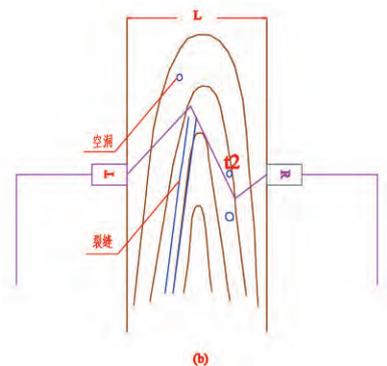
图 4b

4b. 表示空洞和裂隙的木材超声波传播路径

强度相对较高。现有资料显示 D4 为更换过的新木柱, 根据不同高度的波速情况来看, 木柱 D3 的波速与 D4 十分接近, 均在 1 600—1 800 m/s 之间, 所以可以推测 D3 也是更换过的新木柱。由于波在空气中的传播速度为 340 m/s, 低于在木材中的传播速度, 所以超声波在穿过带有空隙的木材时波速会明显降低。据此可初步判定, 波速相对新木柱较小的其余受检木柱年代久远且内部拼接已出现开裂。

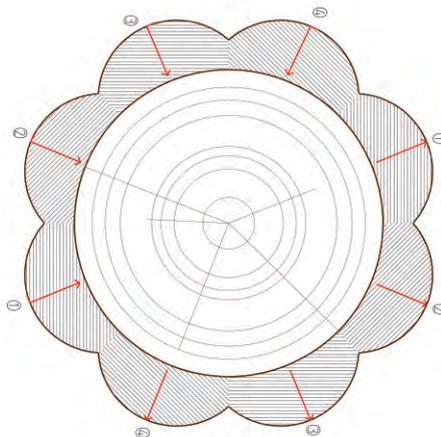
图 5a

均匀分布缝隙，所以检测时须确保每个瓜棱都至少被检测一次（图 5a）；对于直径大于仪器检测范围（60 cm）的木柱，采用两侧对穿的方式进行测试，尽量保证相对的两个检测方向在同一条直线上（图 5b）。

图 5 木材阻抗检测方法（图片来源：同图 3）

5a. 穿透式检测方法

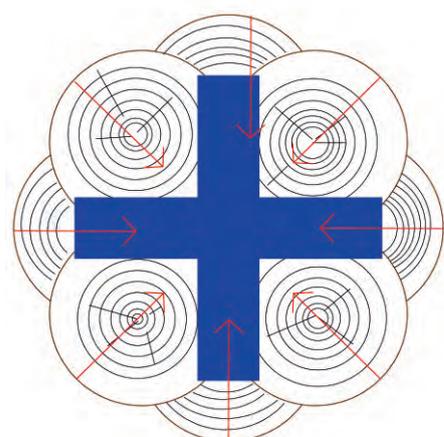
图 5b

5b. 对穿式检测方法

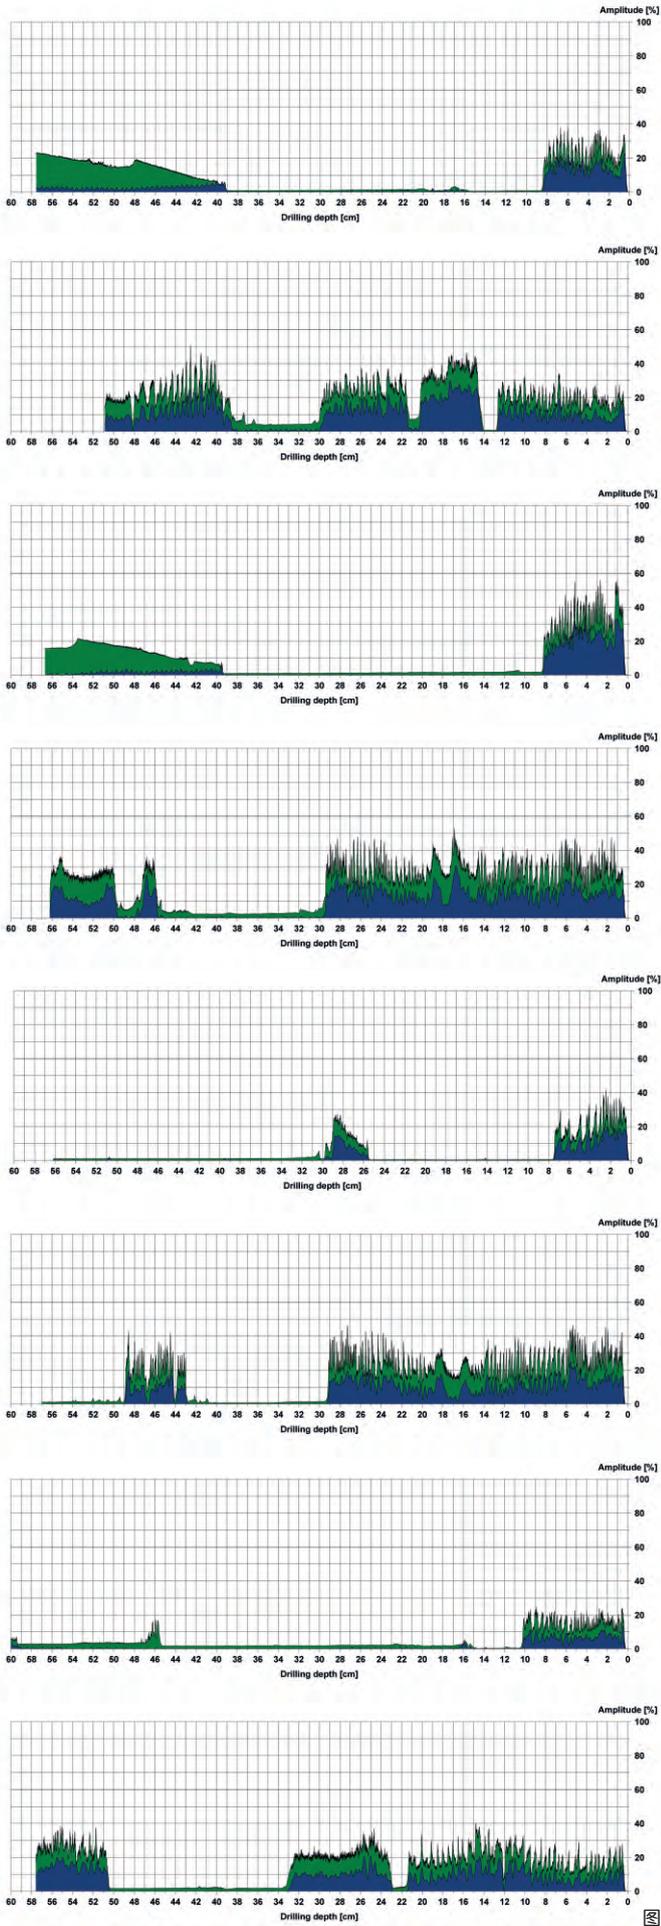
现场检测后，采用 PD-Tools Pro. 软件对测试结果进行阻抗曲线整理，结果如图 6。结合木材密度、年轮等相关木材学知识，对阻抗曲线进行分析，将阻抗曲线合成在木柱横断面上，并用 AutoCAD 软件绘制各测试高度不同程度的腐朽空洞截面图（图 7）。图中蓝色部分代表空洞，红色部分代表严重腐朽，黄色部分代表轻微腐朽，最后得出八瓣包镶柱、四木合柱、整木柱三类木柱的内部腐朽空洞的检测结果。

图 6 阻抗曲线整理（图片来源：陈琳绘制）

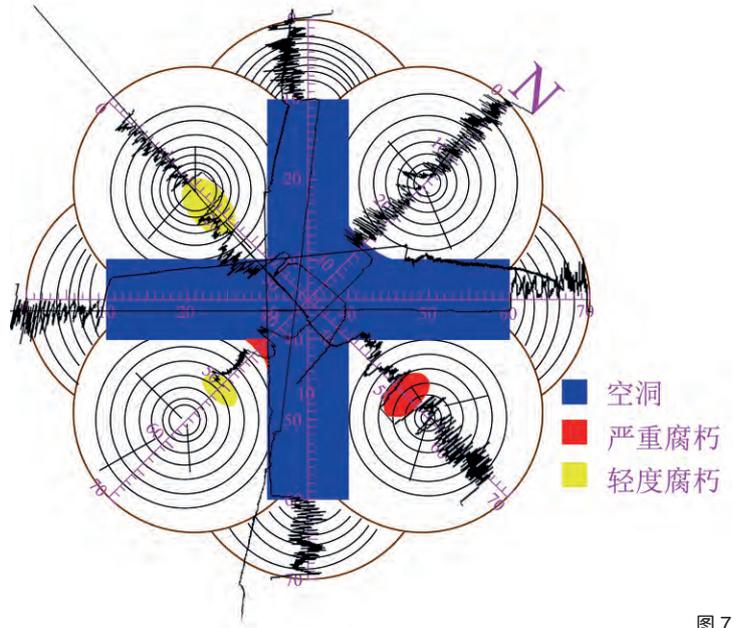
图 7 B3 距离柱础 50cm 高度腐朽空洞截面图（图片来源：同图 6）

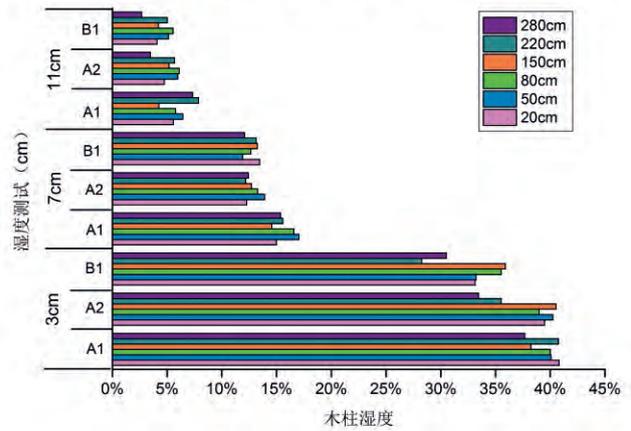
图 8a

从图 8 我们可以看出，对于任何一根木柱，都存在以下规律：同一高度，测试深度为 3 cm 的湿度最大，7 cm 次之，11 cm 最小。对于木柱而言，水分传递路径主要分为三个：从空气中吸收水分；自上而下进入木柱的水分，主要包括屋面漏雨或生物（如蝙蝠）排泄物中的水分；石柱础的冷凝水沿着柱底木纤维传递到木材内部（图 9）。如果是从后两种路径传递的水分，木柱同一高度部位不同深度的湿度差别不会十分明显。由此判断，保国寺大殿宋柱的水分传递路径主要是第一种，即从周围环境吸收水分向木柱内部传递。

八瓣包镶柱（无损微波测试法）湿度情况测试对照图

图 8 微波检测结果（图片来源：同图 6）

8a. 八瓣包镶柱微波检测图

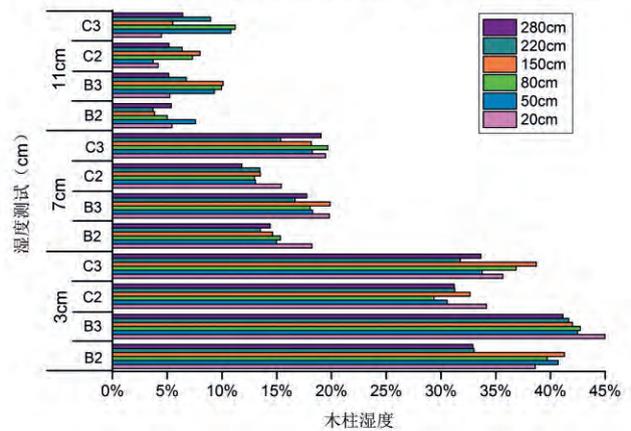
图 8b

四木合柱（无损微波测试法）湿度情况测试对照图

8b. 四木合柱微波检测图

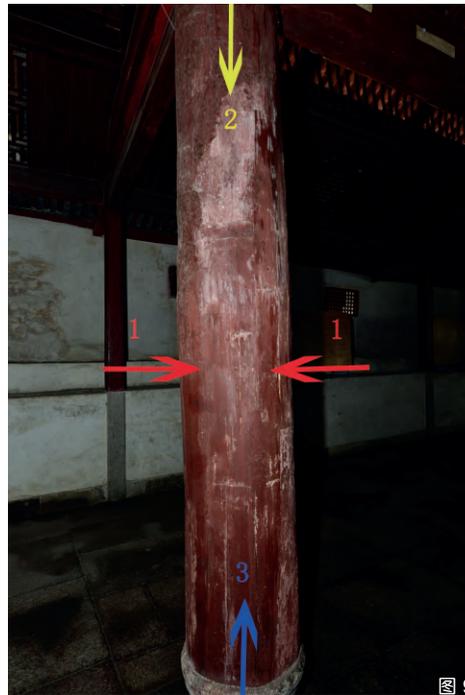
图 9 木柱水分传递路径示意图 (图片来源: 陈琳绘制)

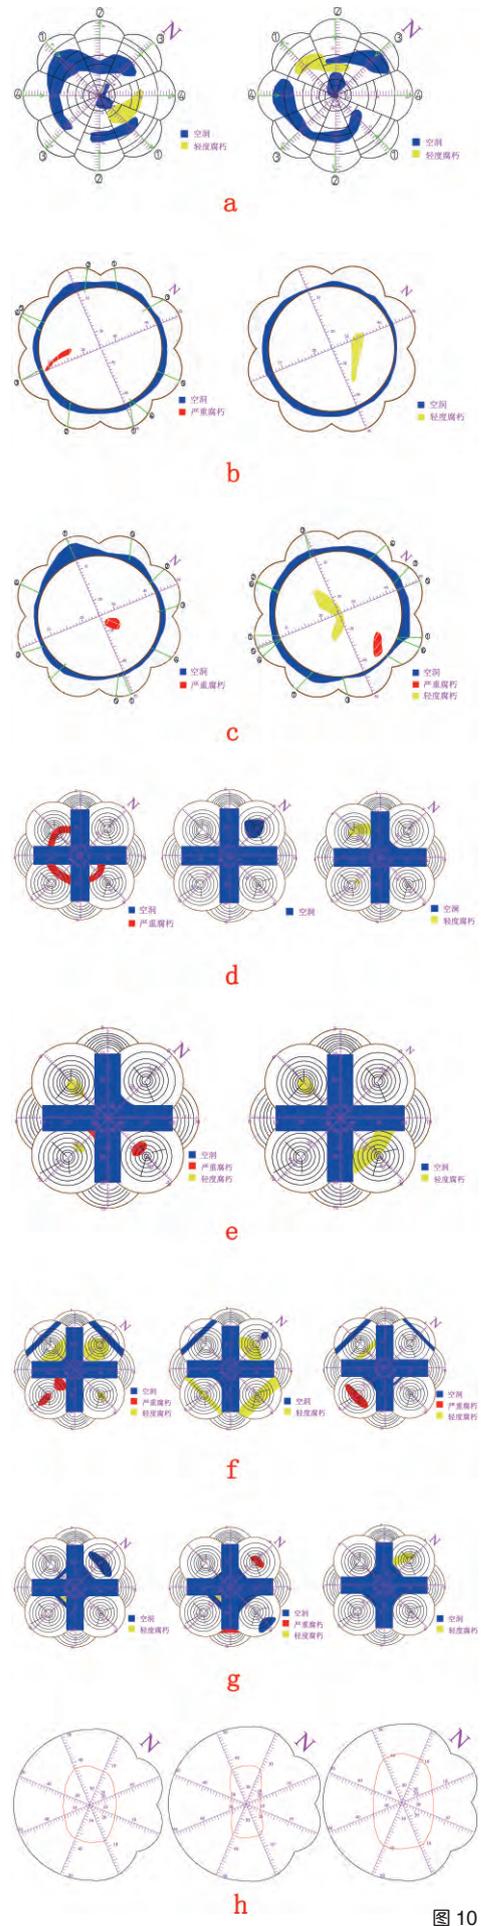
图 10 木柱腐朽空洞截面图 (图片来源: 同图 10)

图中 a 表示柱 A1 距离柱础 50 cm、80 cm 高度木腐朽空洞示意图; b 表示柱 A2 距离柱础 50 cm、80 cm 高度木腐朽空洞示意图; c 表示柱 B1 距离柱础 20 cm、50 cm 高度木腐朽空洞示意图; d 表示柱 B2 距离柱础 20 cm、50 cm、80 cm 高度木腐朽空洞示意图; e 表示柱 B3 距离柱础 50 cm、80 cm 高度木腐朽空洞示意图; f 表示柱 C2 距离柱础 20 cm、50 cm、80 cm 高度木腐朽空洞示意图; g 表示柱 C3 距离柱础 20 cm、50 cm、80 cm 高度木腐朽空洞示意图; h 表示柱 C4 距离柱础 20 cm、50 cm、80 cm 高度木腐朽空洞示意图

检测结果显示, 木柱 A1 所检测部位腐朽严重, 木柱 C2、C3 所检测部位腐朽程度一般, 木柱 B1、B3 所检测部位腐朽程度轻微, 木柱 A2 所检测部位腐朽空洞程度良好, 木柱 B2 所检测部位随着木柱高度增加腐朽空洞程度由严重、轻微向良好过渡。而木柱 C4 由于内部存在 20 世纪 70 年代加固使用的环氧树脂, 腐朽空洞情况不详 (图 10)。

根据《古建筑木结构维护与加固技术规范 GB 50165-92》<sup>[30]</sup>6.9.1 条规定, 木材内部因虫蛀或腐朽形成中空时, 若表面层完好厚度不小于 50 mm, 可采用不饱和聚酯树脂进行灌注加固。鉴于环氧树脂易老化的缺点, 我们可以尽量避免单纯采用其进行加固, 而是先用相同或相近树种的木材进行填充后, 再在缝隙中浇灌环氧树脂进行粘附和加固。
