Installation of an environmental monitoring system in the Chapel of Our Lady of Guia, Macau

Zhong Tang & Shi-Bing Dai

Keywords: Chapel of Our Lady of Guia, Conservation, Diagnostic techniques, Environmental monitoring system

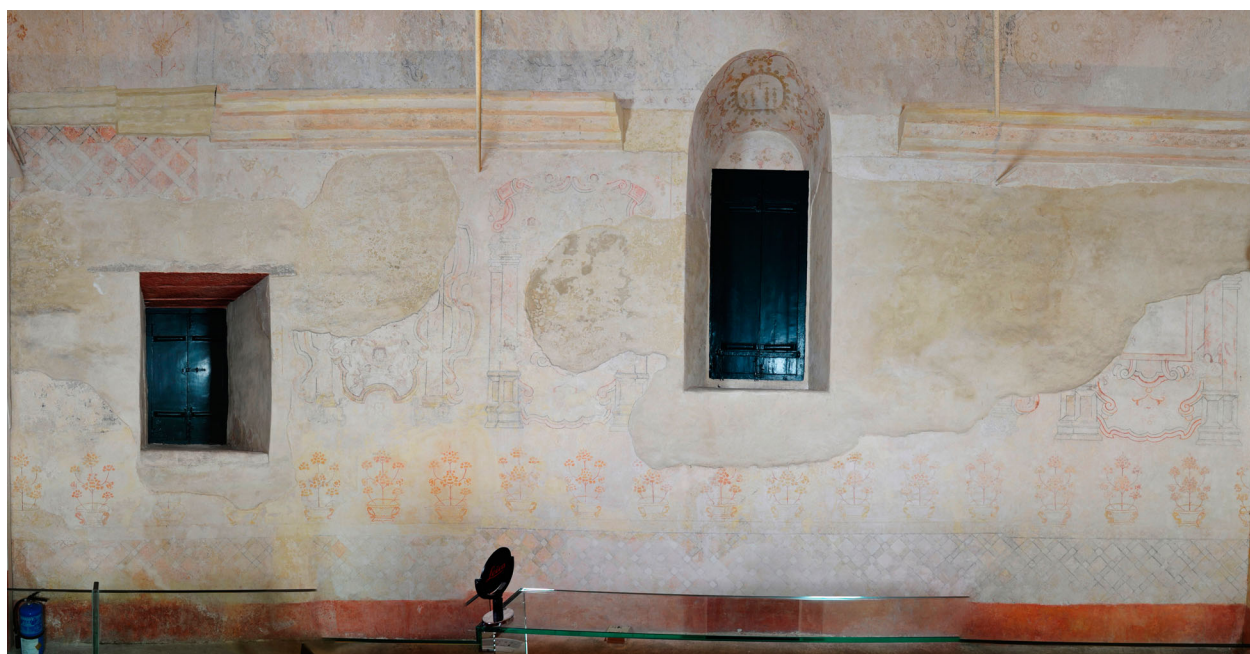
Figure 2 Wall paintings on the north wall of the front hall of the Chapel.

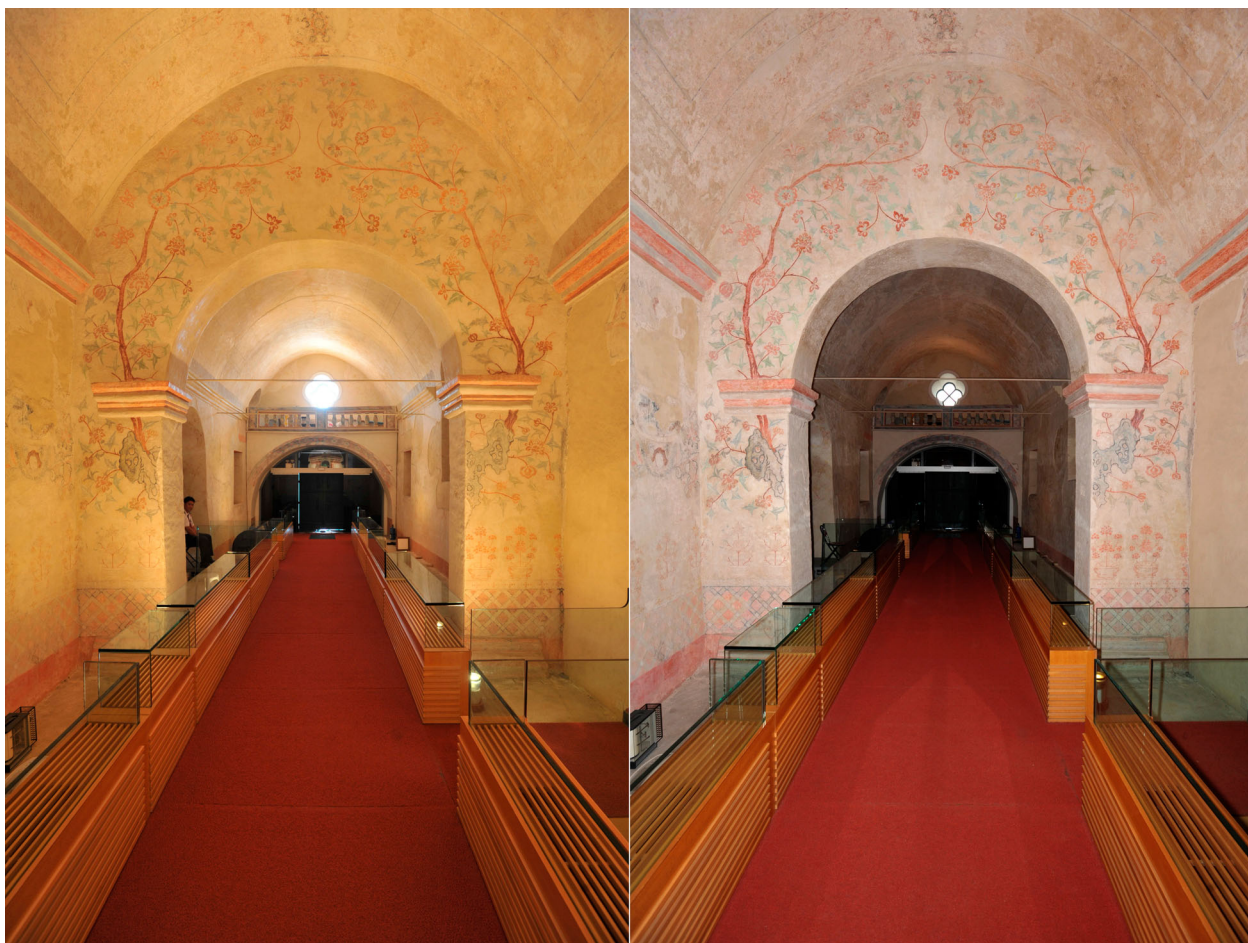
At present, a warm lighting system is used to illuminate the interior of the Chapel to produce an atmosphere appropriate to religious art, which is not suitable for recording the colours of the paintings. It was therefore necessary to use professional lighting equipment with a higher colour temperature (5400 K) (Fig. 5).

Figure 5 Different colour temperatures of the lighting caused different colours to be recorded.
