Bauinstandsetzen und Bauphysik

Conservation of Built Heritage in China

- with a Focus on Material Conservation

Dr. Shibing Dai¹ and Gesa Schwantes²

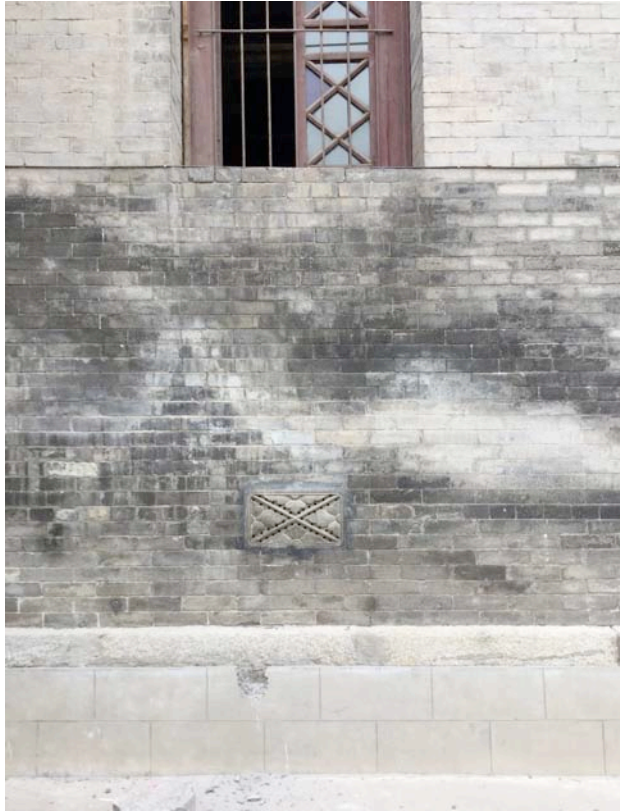
Bild 1: Cement plaster used for repairs of a brick wall at St. Francis Cathedral, built 1716 in Xian. The repair work at the wall base as well as repairs to the damaged bricks were carried out with incorrect materials (cement) causing damage to the original façade.

But despite the development of conservation principles and the growing number of declared and listed national and world heritage sites, China's built heritage continues to be threatened by rapid development and the profit local governments can gain from land sales that involve the demolition of existing structures. Another serious problem is the lack of education in heritage management of bureaucrats working in local cultural departments. While conservation principles are revised and improved and more and more people in China are educated in the growing numbers of available educational programs on heritage management, often there is a lack of basic understanding of materials and the development of conservation techniques. As a result, incorrect materials and measurements are applied in numerous conservation projects, which do not consider the basic physical and chemical properties of the historic fabric. Many of these conservation interventions have caused more damage to the historic fabric than natural decay before the treatment (Bild 1: p 3).

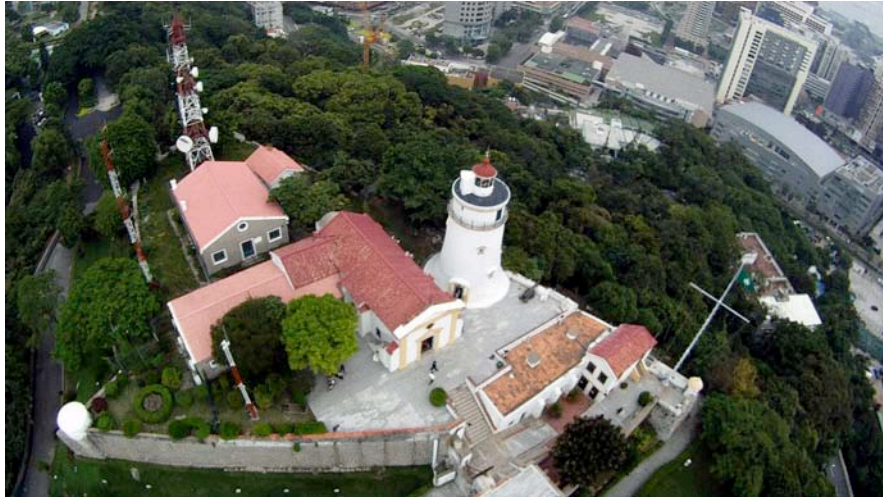
Bild 2: Conservation of the Guia Chapel in Macao, an example of international cooperation between Tongji-ACL and national and international institutes.

The Tongji ACL was founded in 2008. It is a research and teaching laboratory under the College of Architecture and Urban Planning. It comprises specialized laboratories in the conservation of wood, stone, lime plaster and bricks and earthen architecture. It is working under 2 key pillar national research projects and two national science funds. It also collaborates with municipal government agencies to carry out research on local architectural materials, climate monitoring and controlling, and sustainable conservation techniques. An example is the research project on the conservation of the Igreja de Nossa Senhora da Guia in Macao. The project used environmental monitoring, hygrothermal simulations as well as analysis of the impact of variation between the air-conditioned indoor and subtropical outdoor climate on the condition of the building fabric and material analysis. In addition, a conservation concept for the wall paintings was developed (Bild 2: p. 7).

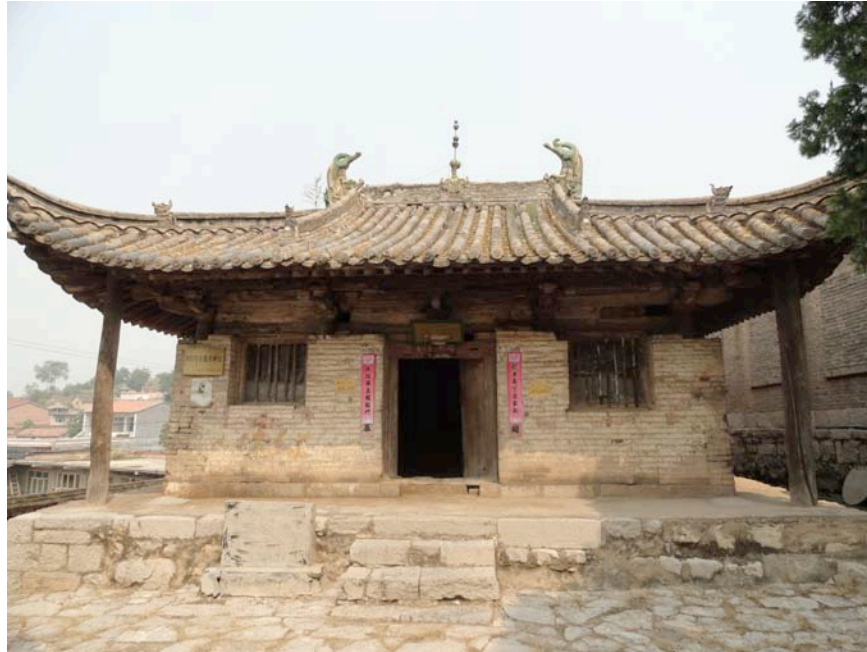
Bild 3: Example of traditional roof of a Tang Dynasty temple with ridgeline figures located in Shanxi Province.

Temple complexes in the Shanxi Province are known as some of the most beautiful and elaborately decorated temples in China dating from ca. 11th to 12th century AD. It is known that approximately 50% of the existing remaining historic buildings in China from this time period are located in the southern Shanxi Province. A large number of these historic buildings were built with richly decorated traditional wood construction. The building decoration includes engraved bricks, stone carving, woodcarving, painted woodwork, wall paintings and painted sculptures giving these buildings and their decoration high artistic and historical value. The temple roofs are typically tiled with different types of traditional Chinese ceramic tiles, usually in the monk and nun or imbrex and tegula style, glazed or unglazed and bound with lime or clay mortar. Often the ridges, especially towards the gable, are decorated with specially arranged tiles or ceramic figures and every row of tiles towards the eaves is finished with a special decorated tile (Bild 3: p. 11).

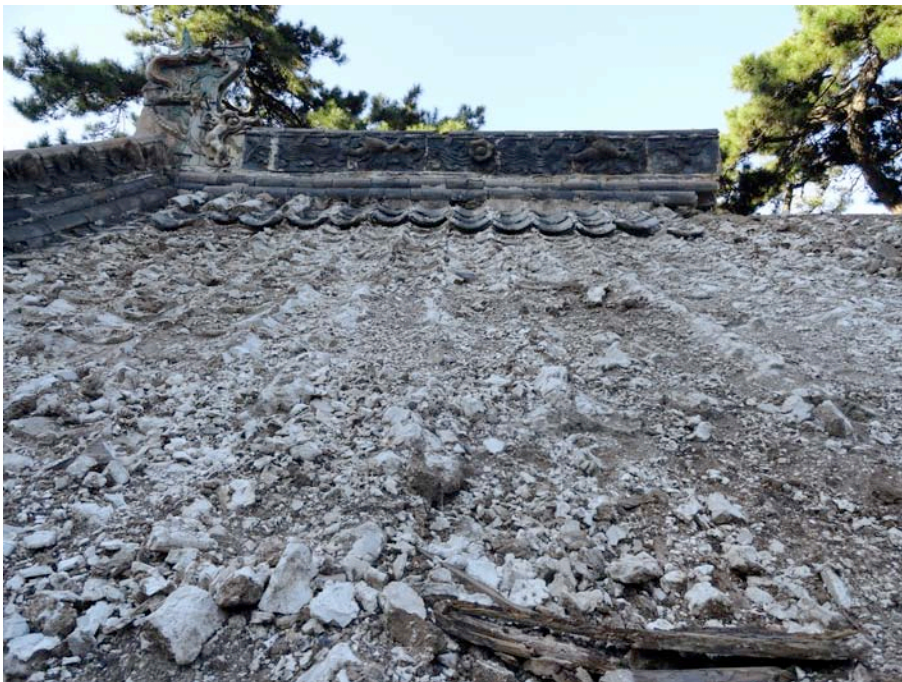
Bild 4: Roof construction details. Differences in plaster material used for tiling were investigated.

The aim is to gain a detailed understanding of the physical conditions and define weakness and sources of damage. Comparing a large number of sites has demonstrated differences in the quality of the techniques used for roofing. Pure lime plaster, for example, has shown to be a more durable and show better performance used as binding mortar between the tiles than lime-clay plaster (Bild 4: p. 12). It is assumed that differences in the plaster are partly due to availability and prices of these resource materials. A specific type of Chinese roof tile, the Qing Gun tile,

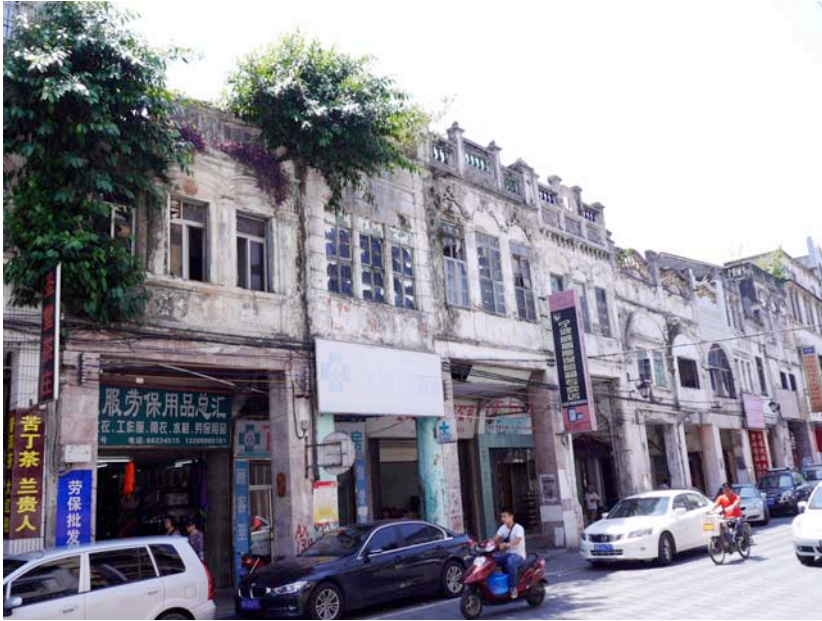
Bild 5: Shop-houses in Haikou, on North Boai Road, before conservation.

The historic centre of Haikou City, the capital of Hainan Island Province in the South China Sea, features several areas with contiguous street façades of historic shop-houses built before the 1930's. These primarily two-three storey buildings integrating Chinese and European architectural styles can mainly be found in South China and Southeast Asia (for example at Malaysia's UNESCO World Heritage site *Melaka and George Town, Historic Cities of the Straits of Malacca*). The shop-houses are built as row houses and usually feature a commercial unit on the ground floor open towards public sidewalk arcades with residential units above (Bild 5: Bild 6: p.14).

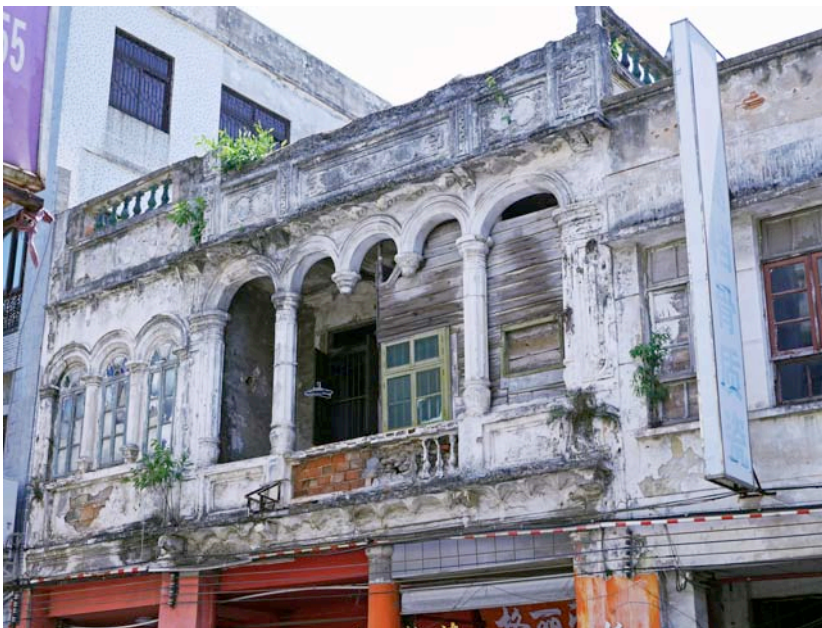
Bild 6: A shop-house in Haikou City, on North Boai Road, before conservation.

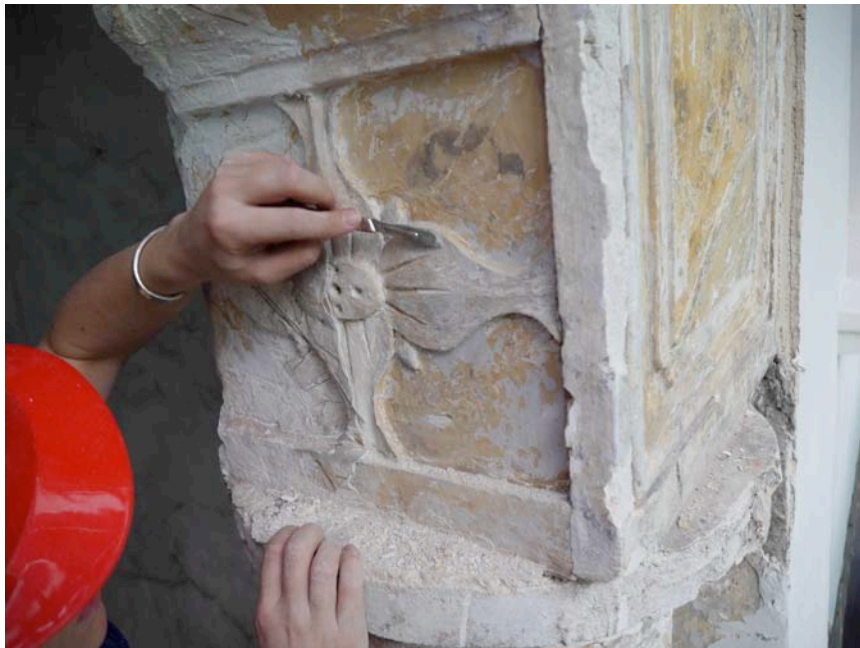
Bild 7: Colour investigation and exposure of decorative plaster at a shop-house in North Boai Road in Haikou before conservation

In 2010, the Tongji ACL was invited to consult with the local government in the restoration of the shop houses along Zhongshan Road in Haikou. The proposed restoration work however was mainly limited to focus on the upgrading of the facades. The original coloured lime plaster façades and wooden window frames were restored using historic painting techniques and the colour scheme for repainting was chosen according to sample investigations of the original materials and colours in the laboratory (Bild 7: p.15). Some extant gratifies and propaganda signs from 1950-1960's were also preserved [Dai et al 2014]. The restoration of shop-houses along Zhongshan Road was successfully accomplished by end of 2012. The local government is making efforts to use the same restoration methods during the current restoration of North Boai Road in Haikou. A publication, "A Technical Guideline for Facade Restoration of Haikou Shophouses" is currently under progress and is expected to be published by October 2015. This publication will highlight the risks resulting from incorrect conservation practices and demonstrate solutions following conservation best practices including detailed specifications for implementation.

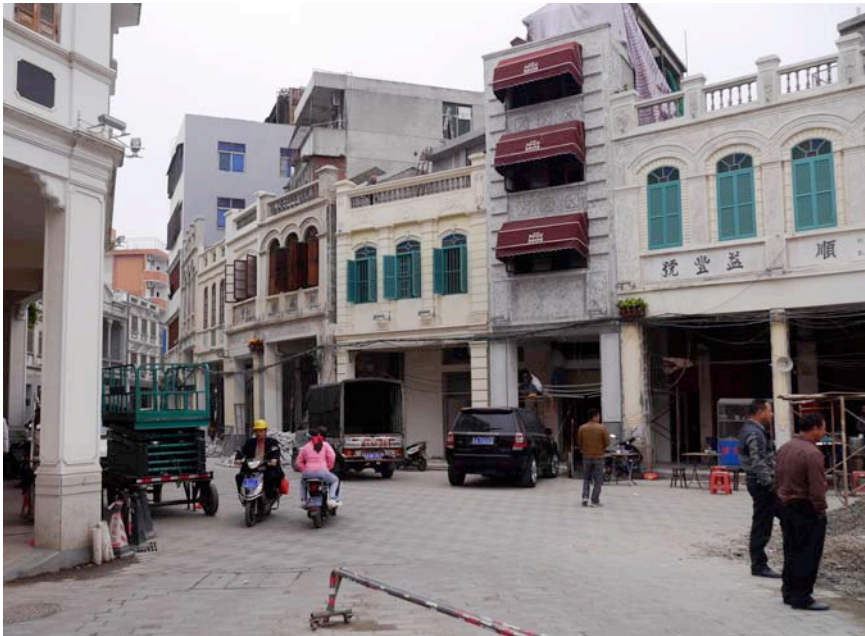
Bild 8: North Boai Road, Haikou after conservation

Local construction companies applied the described conservation approaches to the shop-house facades as is successfully demonstrated at Zhongshan Road more than on other streets, partially related to budgeting issues and time management constraints. Investigation on the decorative history of the buildings was not carried out consistently and the use of appropriate repair materials was not always sufficiently controlled. During site visits by the Tongji ACL - in 2014 for example, new cement repair patches were observed on brick-lime plaster structures. While the original conservation approach for this project included a detailed study of the original wooden joineries and their decoration and was intended to maintain and repair several well-preserved wooden components, this was not fully realized in the implementation. The joinery was mostly entirely replaced and while the design was chosen to roughly match the historical examples in general, it does not follow any research done on the individual buildings (Bild 8: p. 16).

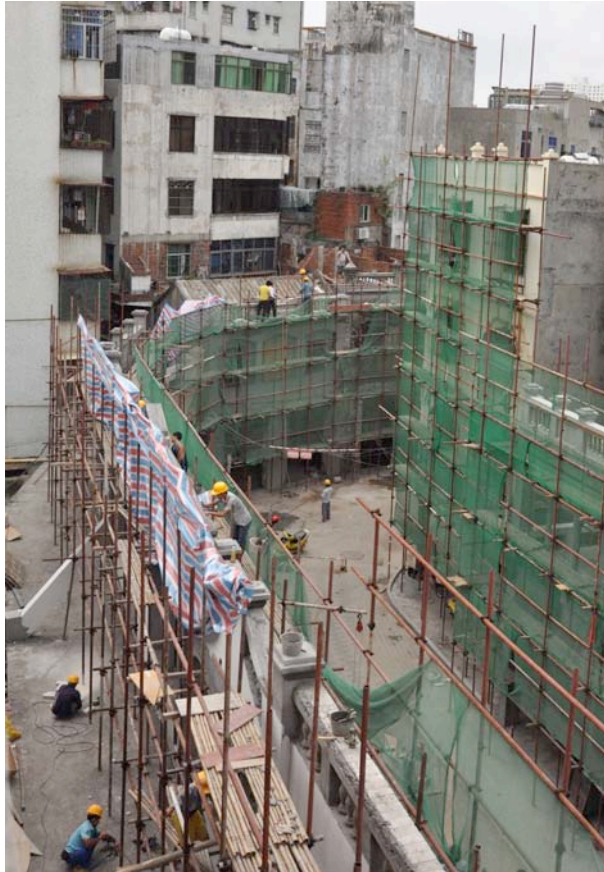
Bild 9: Building of fake shop-house facades in the vicinity of Zhongshan Street, Haikou.

Parallel to this conservation work in the streets with existing historic shop-houses, other streets in the vicinity have been designed with fake historic facades in front of newer structures, which replaced the former shop-houses in the 1950s to 1990s

(Bild 9: p. 17). The presence of the fake shop-house facades clearly shows confusion in application and in the expected results of the conservation of the city centre by the local authorities. In combination with poor interpretation of the sites in the areas where the shop-house conservation work was done properly, the presence of “fake” shop-houses may lead to confusion of the public and visitors in their understanding of the place and in their understanding of proper conservation works.
